Aztec West Business Park, South Gloucestershire

Location Aztec West Business Park, South Gloucestershire Main SuDS used Retention ponds and detention basins, with fountains, to promote the aerobic degradation of hydrocarbons

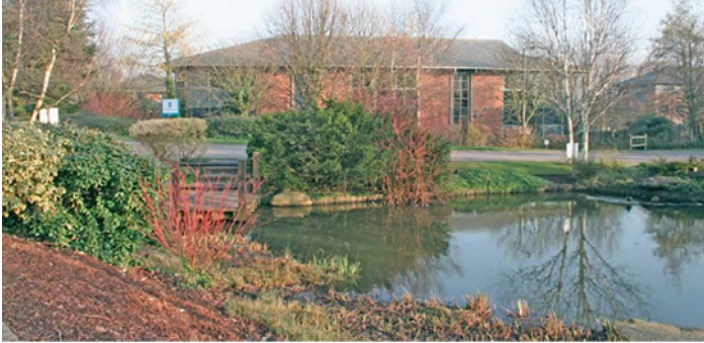
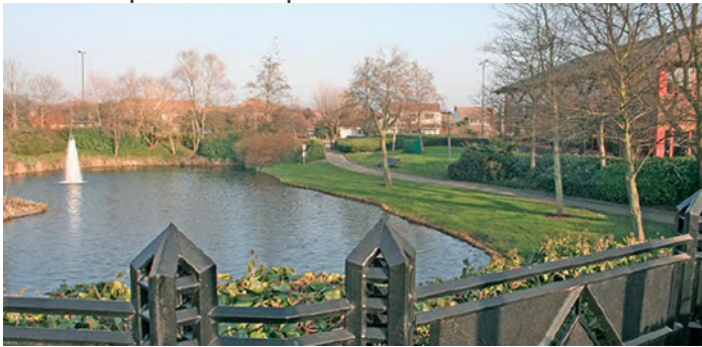
How it works The local authority dictated a limited flow rate of site discharge. The client endorsed and encouraged this solution, whereby excess water is dealt with in a high quality, aesthetically pleasing way. The site has a series of ponds arranged in series, two retention ponds with permanent water and then a detention pond which remains dry most

of the time.

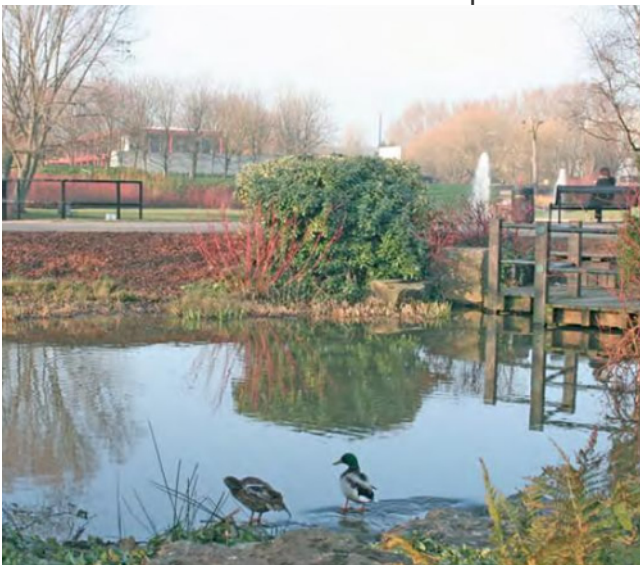
Specific details The system is discussed in detail by Aidan Millerick in 'A Review of 20 years of SuDS specifications in the UK including a review of the operational experience of a 22 year old SuDS system and how recent developments may alter the design approach'. The large amenity ponds were fed from road and car park drainage. Instead of costly oil separators to pre-treat runoff, large ornamental fountains were installed to aerate the water and promote breakdown of hydrocarbons.
