Victoria Park Health Centre, Leicester

Description The Victoria Park Health Centre (VPHC) development is a two-storey health centre. The site is roughly 0.7 hectares in size and the site of a WW11 air raid shelter. Work began on the health centre in 2010 and was completed in winter 2013. The landscape design approach was intended to 'tie' the proposed scheme into its context and protect and enhance the landscape setting. The landscape design was developed in tandem with the architectural layout, to ensure that the proposal 'sits' comfortably within the existing landscape.

Main SuDS used

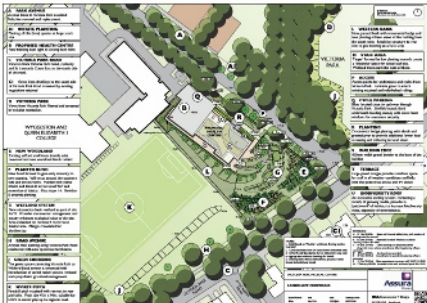
Figure 2: Landscape proposals (click image to enlarge)

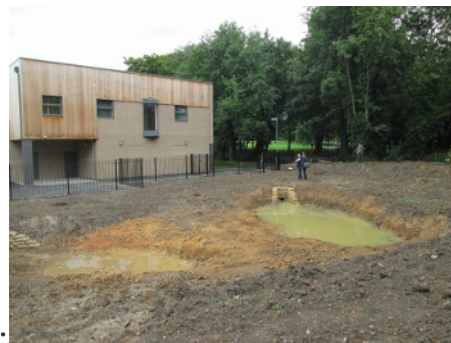
The infiltration basin during construction

It was envisaged that the wetland would not contain permanent water, since it would not be lined, but would function instead as 'marsh', drying out in warm weather. As such the basin has been planted with mixed marginal species such as reeds, sedges, rushes, yellow flag iris and purple loosestrife. The surrounding landscape has been carefully contoured and is seeded with a mixture of wetland grass and wildflower species such as stalked meadow grass, red clover and birdsfoot trefoil. Native trees were planted to provide a strong landscape framework. It is anticipated that because the deeper sections of the basins hold more water, they will develop taller emergent and marginal planting, whilst the shallower sections and those that dry out more frequently will favour sedges and grasses. It was originally intended that swales would link the building to the basin, however space requirements led to the engineers designing a conventional pipe system. This has changed the number of treatment stages available for the car park runoff. Towards the end of the project the contractor made the gradients around the marshes too steep. It was necessary to meet on site and agree to form more gentle slopes. The site is subject to a landscape management plan (LMP). The contractors that installed the landscape are covering the 12 months maintenance of the site and DSA have been

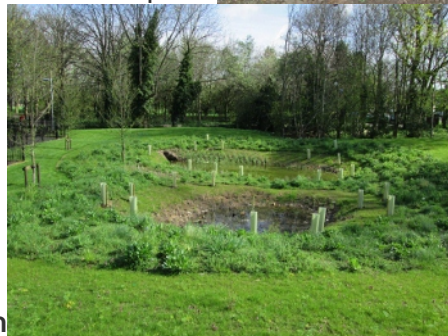
Figure 7: The infiltration basin with wildflower turf and grass seeding

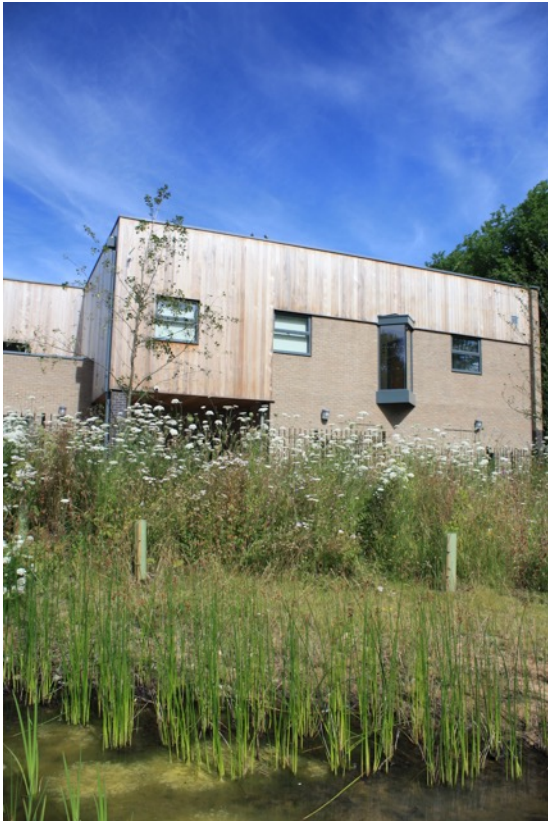
Figure 11: The Swales continuing to work well

Update May 2016: The swales continue to work well to this day, with the DSA team regularly monitoring their performance. With much of the planting now established on site, a fantastic environment has been created for wildlife. The site attracts Honey bees and Broad Bodied Chaser.
