# Victoria Park Health Centre, Leicester

## SuDS used

- “Biodiversity” roof
- Infiltration basin
- Wetland

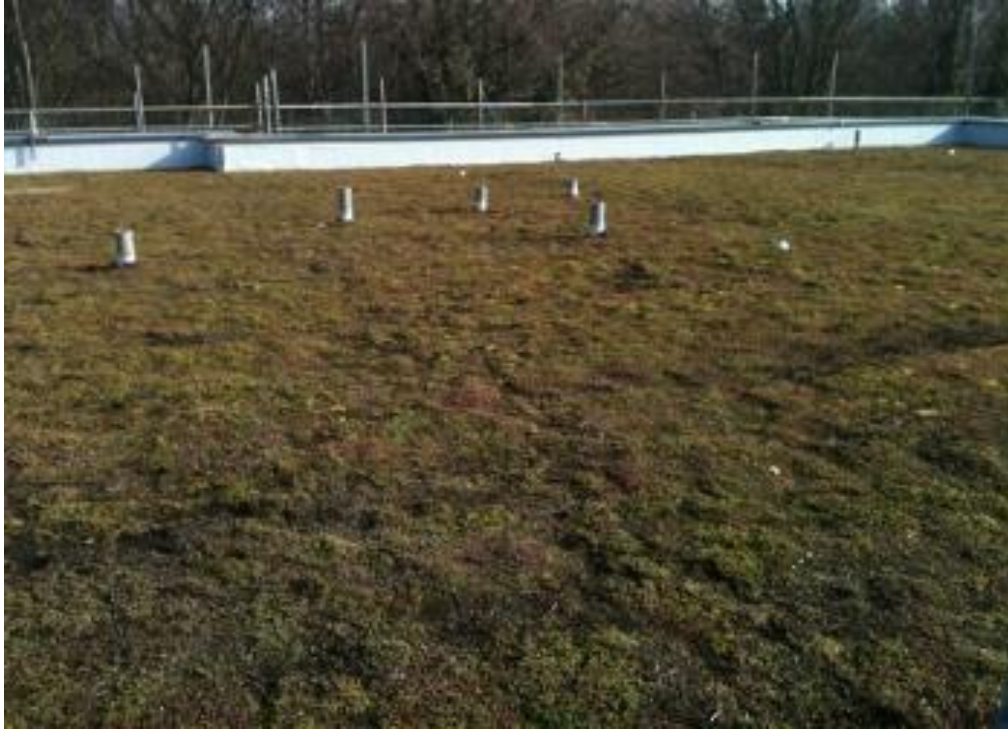
Figure 3 Biodiversity green roof. An all in one modular green roof system with an extensive sedum and lightweight soil-less wildflower mat laid over a 79-80mm substrate

The proposal to construct a two storey building in green space in the centre of Leicester demanded sensitive design. It became clear that dealing with the site's water runoff would require an innovative approach. Early investigations revealed that percolation of water into the ground was a suitable option and so a SuDS scheme was developed, incorporating a 'biodiversity' roof and an infiltration basin.

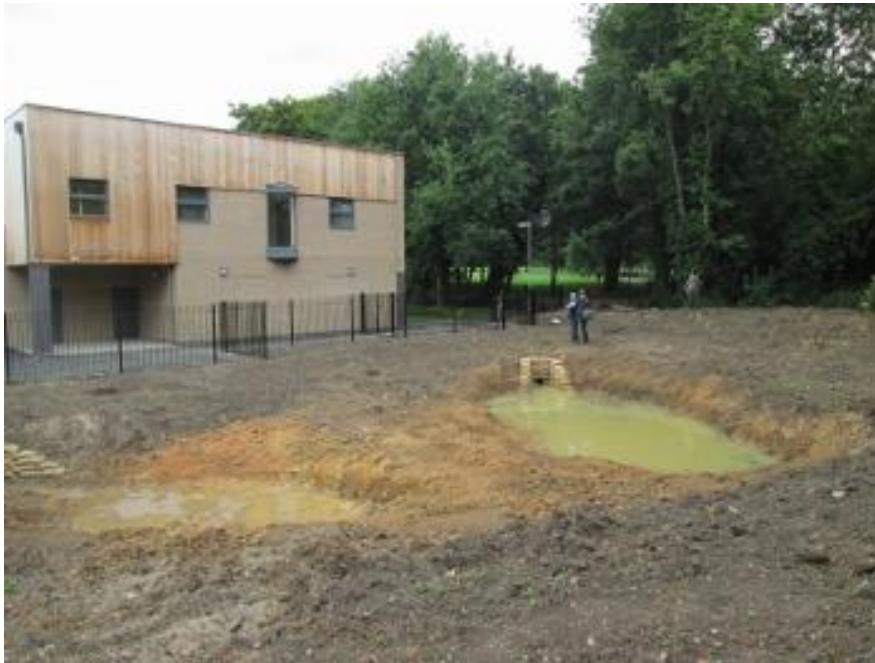
Figure 6 The infiltration basin during construction

Towards the end of the project the contractor made the gradients around the marshes too steep. It was necessary to meet on site and agree to form more gentle slopes.

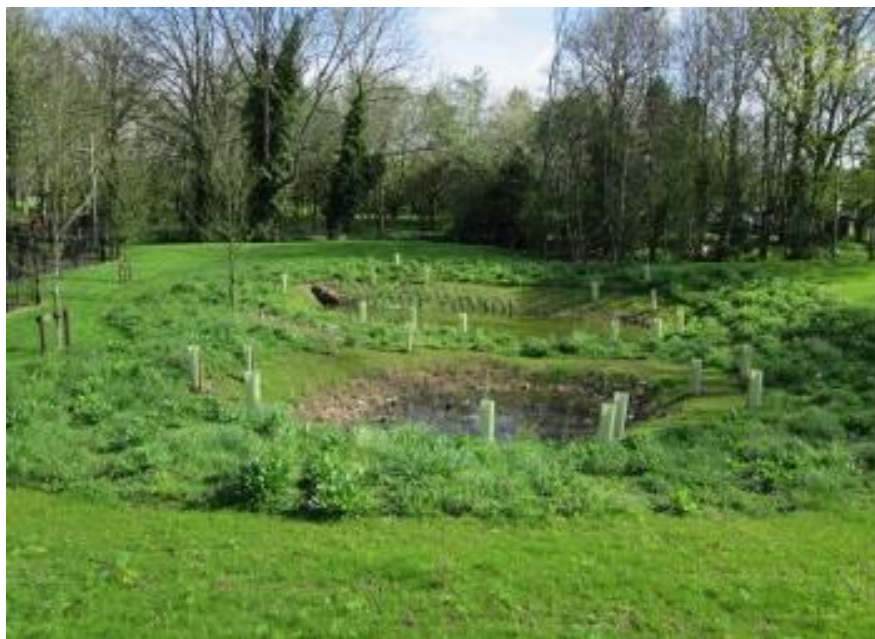
Figure 7 The infiltration basin with wildflower turf and grass seeding

It was envisaged that the wetland would not contain permanent water, since it would not be lined, but would function instead as 'marsh', drying out in warm weather. As such the basin has been planted with mixed marginal species such as reeds, sedges, rushes, yellow flag iris and purple loosestrife. The surrounding landscape has been carefully contoured and is seeded with a mixture of wetland grass and wildflower species such as stalked meadow grass, red clover and birdsfoot trefoil. Native trees were planted to provide a strong landscape framework.

It is anticipated that because the deeper sections of the basins hold more water, they will develop taller emergent and marginal planting, whilst the shallower sections and those that dry out more frequently will favour sedges and grasses.

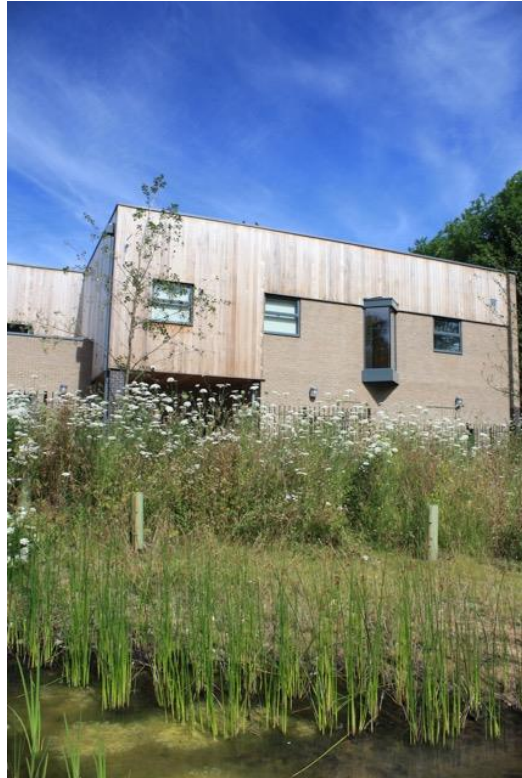
Figure 10 The Swales continuing to work well

The swales continue to work well to this day, with the DSA team regularly monitoring their performance. With much of the planting now established on site, a fantastic environment has been created for wildlife. The site attracts Honey bees and Broad Bodied Chaser.
