Business Service Centre, Barry

SuDS used

- *Proprietary rain garden system*

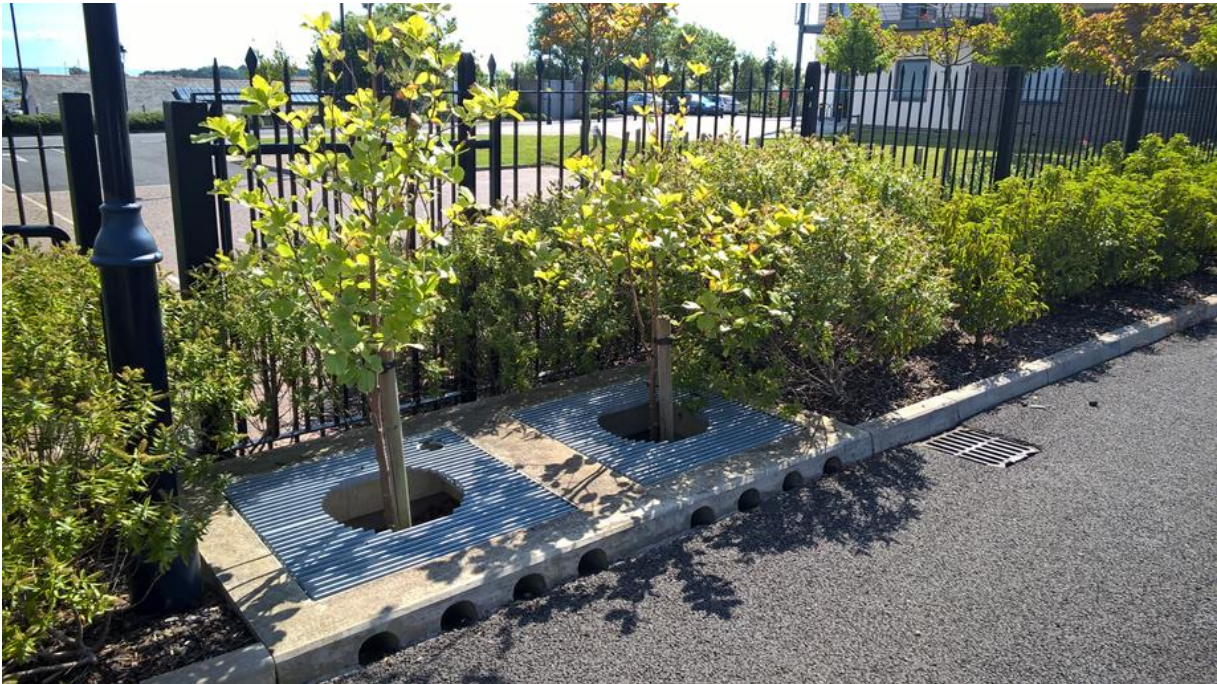
Rain garden system is a self-contained unit that looks like a normal landscape feature from the surface, but contains a dual layer filtration system and effective inlet & outlet structures to accept and filter Stormwater runoff.

Installed in July 2012, this was one of the first UK installations of this type of proprietary rain garden system. Vale of Glamorgan council installed 3 units at the Business Service Centre (BSC) car park to meet environmental quality standards and protect the newly revitalised Barry Dock.

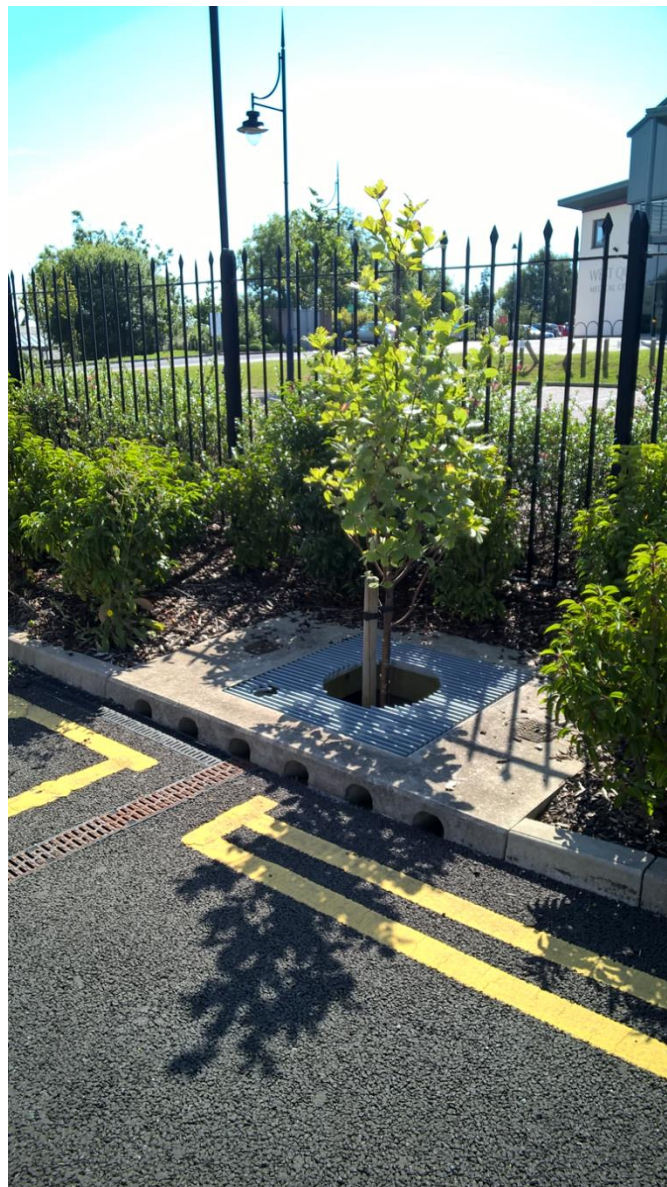
Fig 1: Biofilter unit with combined kerb inlet and channel drain inlet

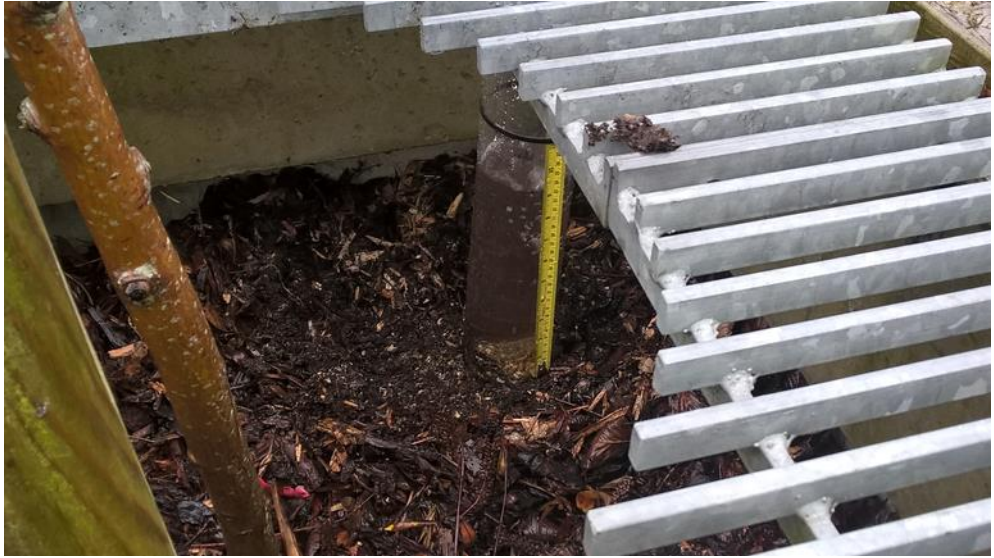
Fig2: Infiltrometer testing

A 2017 return visit by the manufacturer demonstrated that soil infiltration rates through the engineered soil have been maintained effectively by the ecosystem.

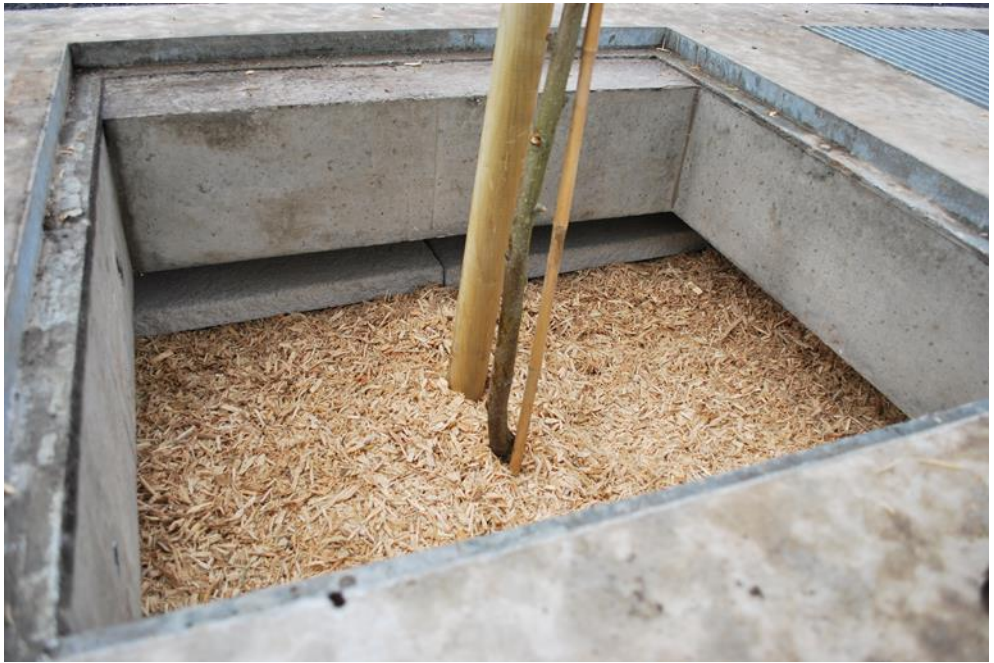
Fig 3: Installation of mulch layer

The manufacturer provided the first year of maintenance to ensure that the plant survives the transplant shock involved with being moved from a nursery into an urban environment and successfully takes to the new surroundings. The system requires an annual inspection and litter pick, along with removal and replacement of the mulch layer.
