Walking the Talk! Whitby Retrofit

9 Westbourne Avenue, Whitby, North Yorkshire, YO21 3NF

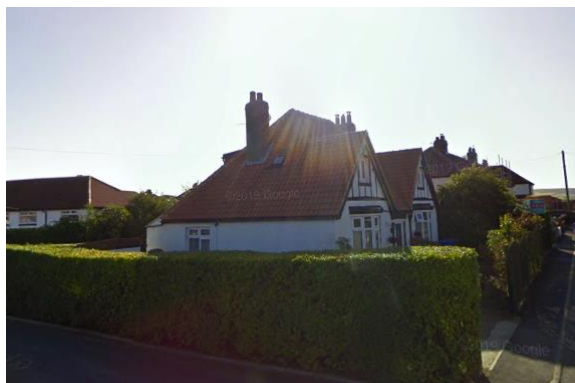
Prior to extension

The guttering serving the original hipped roof of the bungalow was originally connected to a system of very shallow combined private drains which joined the public sewer at the Southwest corner of the plot.

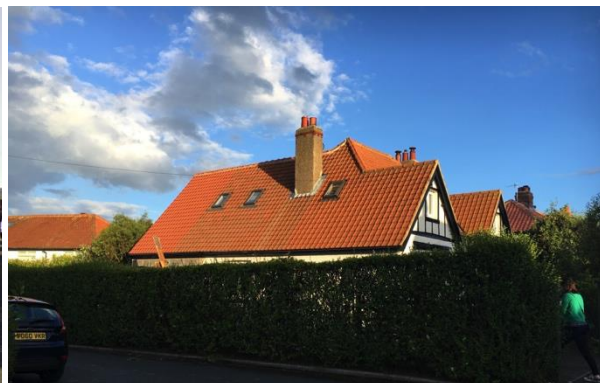
Extended property

The design of the rear extension added a new gable end to the North East quadrant of the building, severing the connection to the rear drainage for a substantial portion of the existing and the new roof area.

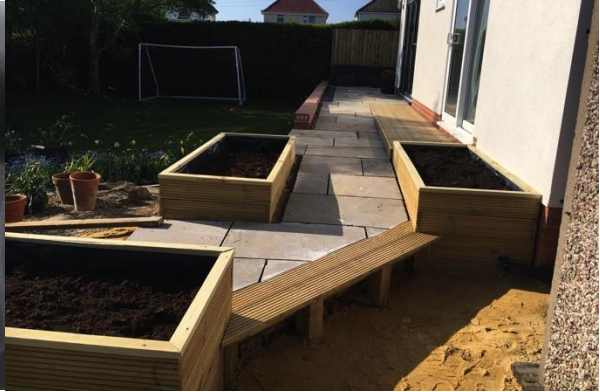
Completed beds

Flow from the roof is collected by a traditional gutter and downpipe, which then runs into the bottom of a series of raised beds, inter-connected by perforated pipework surrounded by a single-size gravel medium. Vertical wicks run through a barrier layer into the soil to facilitate the drawing up of moisture into the soil. The beds are all lined with a waterproof membrane, and an overflow ensures that the level in the beds doesn't waterlog the upper layer of the growing medium.

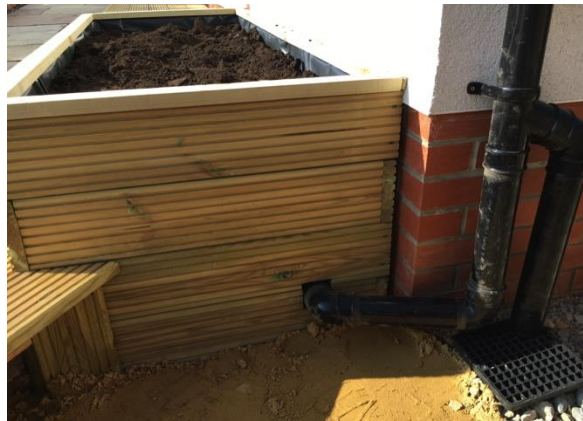
Downpipe connection to raised bed & overflow

The overflow is connected to a rubble-filled trench. Though trench is substantial, the local clay soil meant that this would not have been sufficient without the additional capacity offered by the raised beds.
