Access Road at Jehovah's Witnesses Britain Headquarters, Chelmsford

SuDS used

- Roadside swales
- Pocket wetland
- Attenuation pond

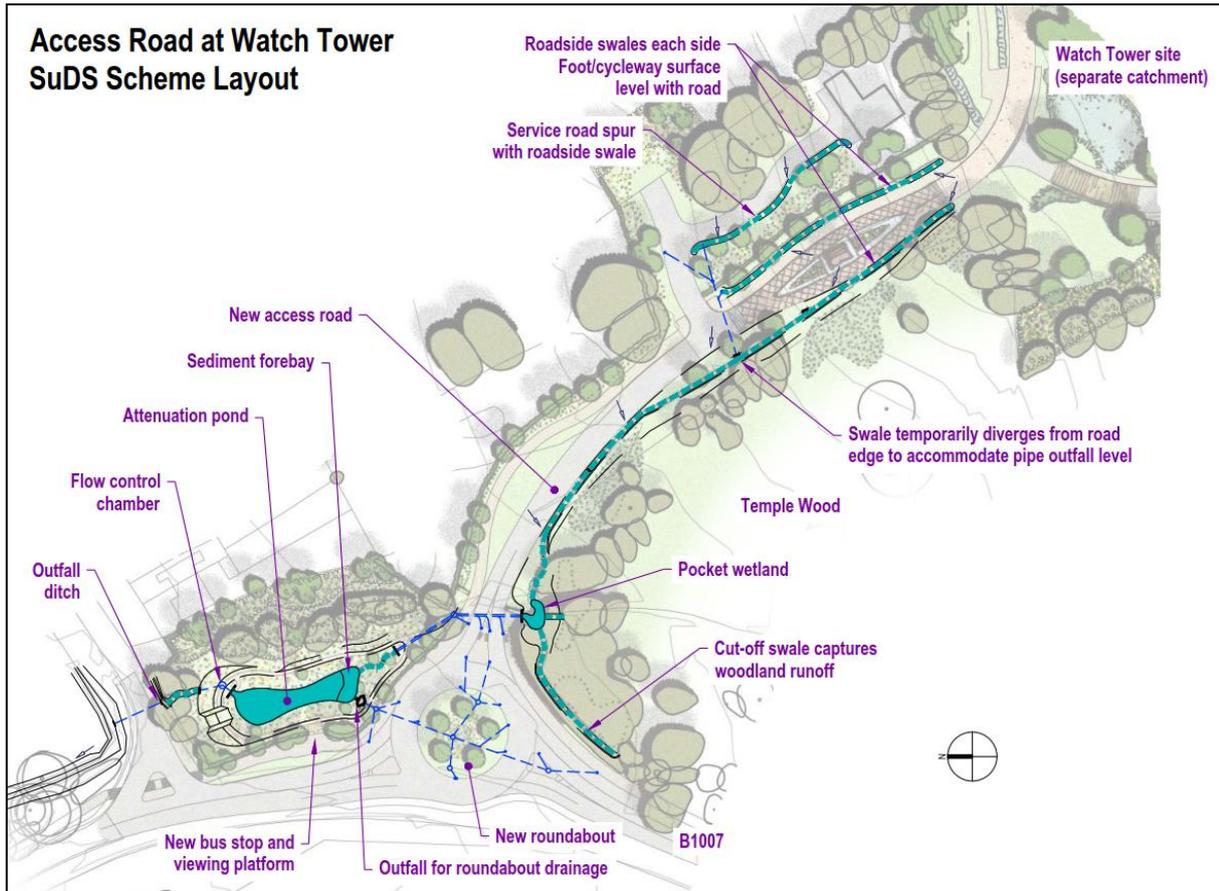
Fig 1

The access road drains via **sheet runoff** into **roadside swales** (stage 1). These then collect in a **pocket wetland** (stage 2). The wetland discharge is piped under the road into a **swale** which cascades into the **attenuation pond** (stage 3). The pond also receives runoff from the new roundabout. The pond outfalls into an existing roadside ditch via a flow control chamber and a length of **swale cascade**.

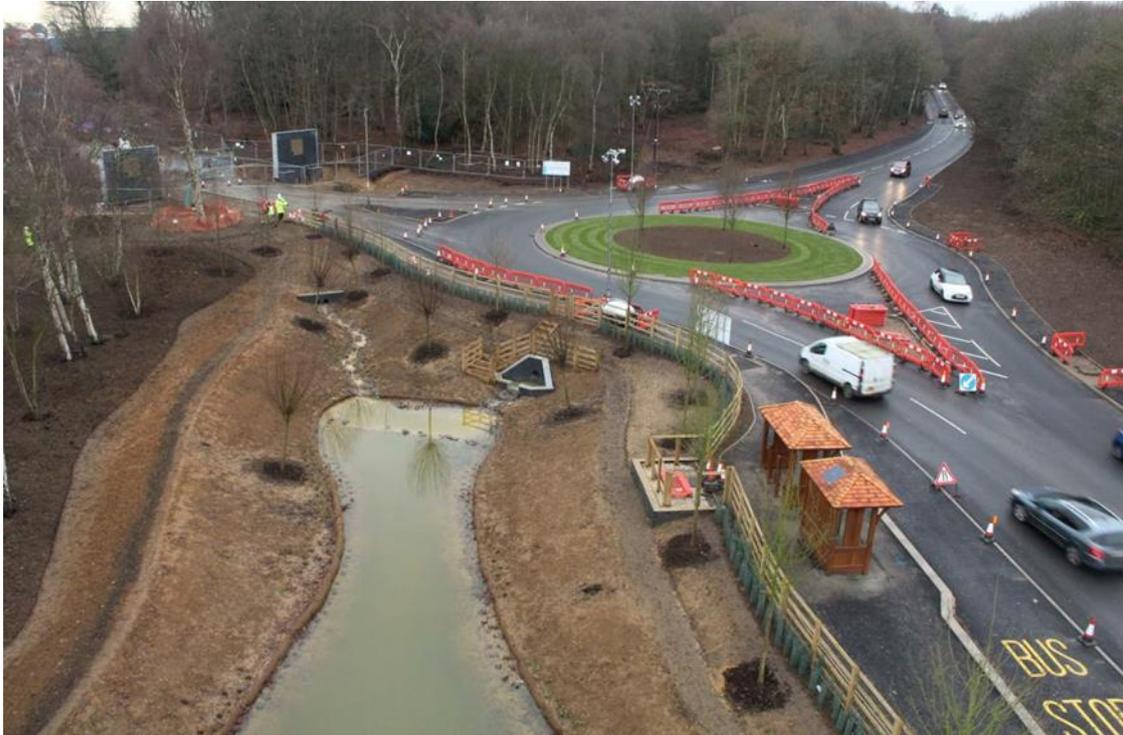
*Soft landscaping works underway at the attenuation pond (Fig 2 above)
Pocket wetland (Fig 3 below)*

The attenuation pond has a sediment forebay zone. Storage of 220m³ caters for the 1 in 100 year event (+20%) at a peak discharge of 5 l/s. Flow control is by orifice plate (with perforated steel basket). Exceedance design comprises 30m³ spare volume and a spillway in the embankment.

Coir rolls create a soft vertical edge at the permanent water line. This helps to avoid muddy margins caused by fluctuation in water level during regular rainfall events.

The pond design included aquatic and marginal planting with aquatic bench and varied depth profile. This helps to balance oxygen levels, reduce algae and support a variety of wildlife, especially insect populations. A regional species garden was created around the pond featuring a variety of native tree and hedgerow planting, increasing available habitat for local species such as dormice.

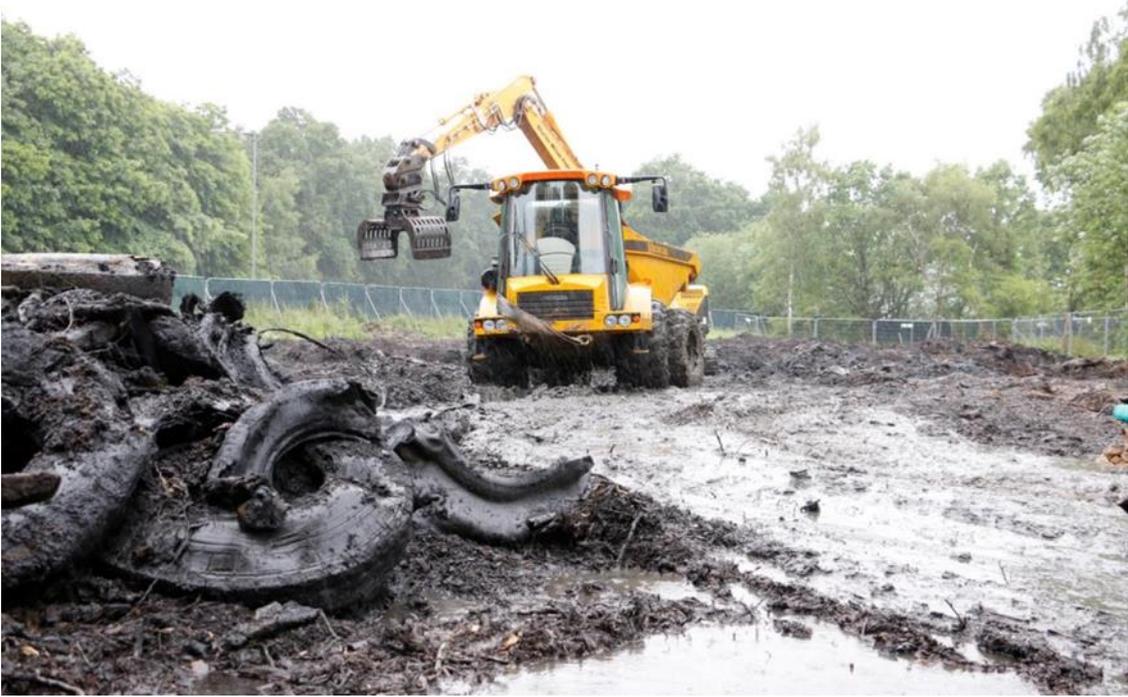
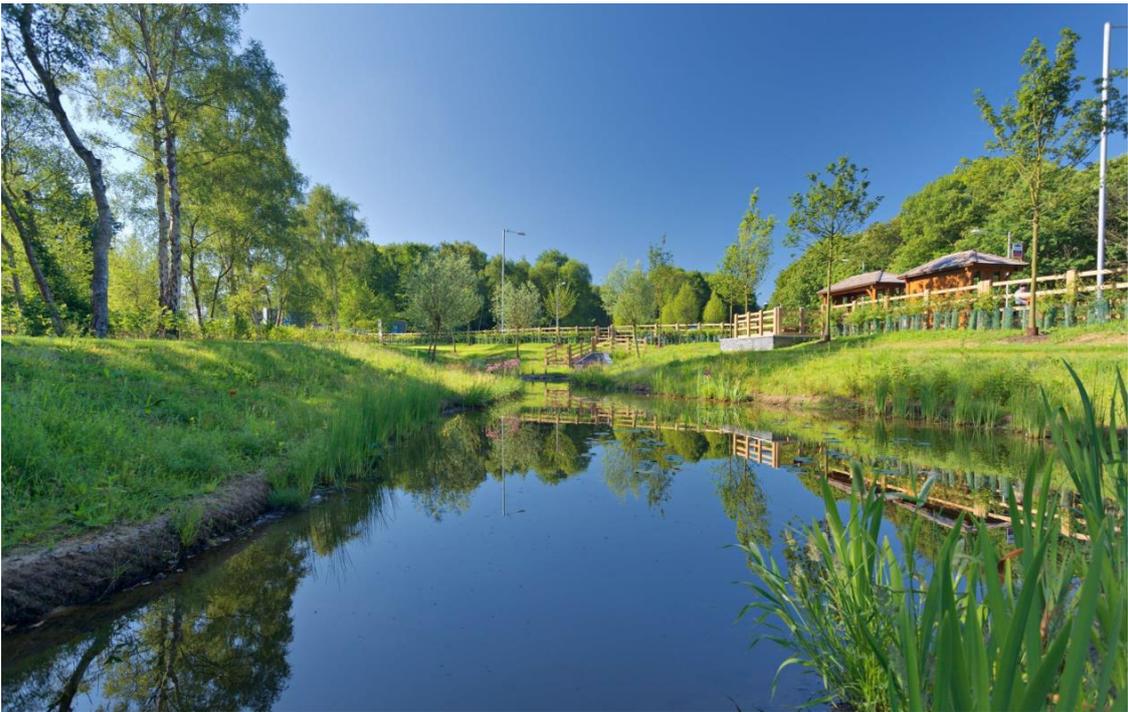
Pond before (Fig 4) and after (Fig 5)

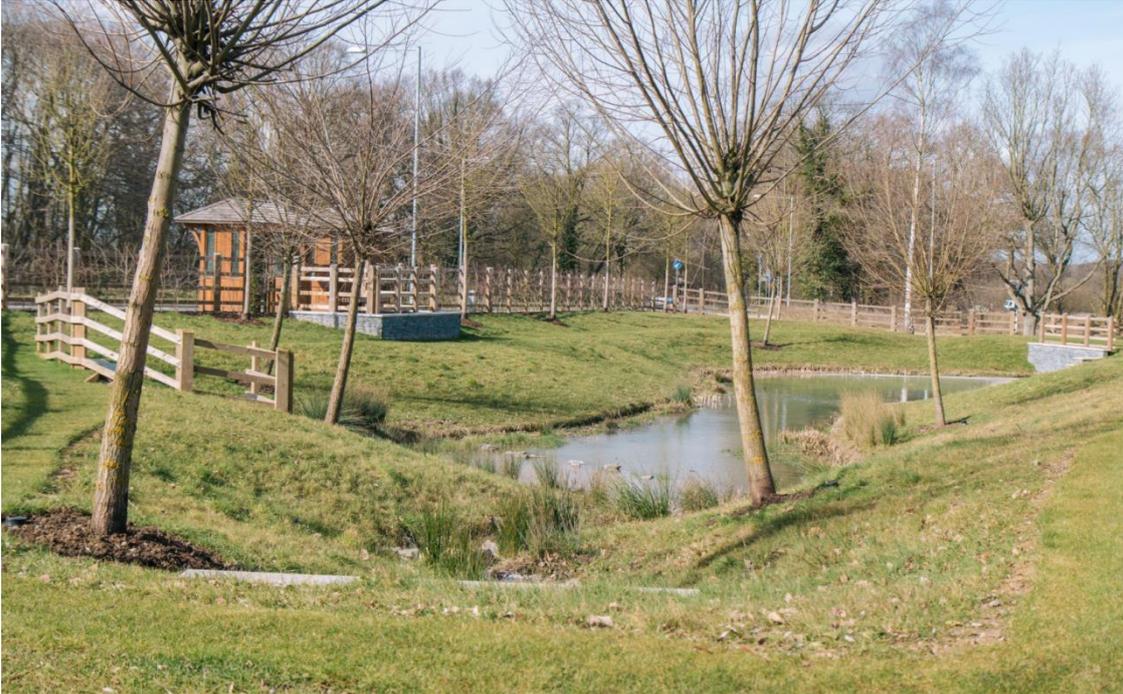
*View of the pond looking downstream (Fig 6 above)
Roadside swale with outlet headwalls (Fig 7 below)*
