Business Service Centre, Barry

SuDS used

- *Proprietary rain garden system*

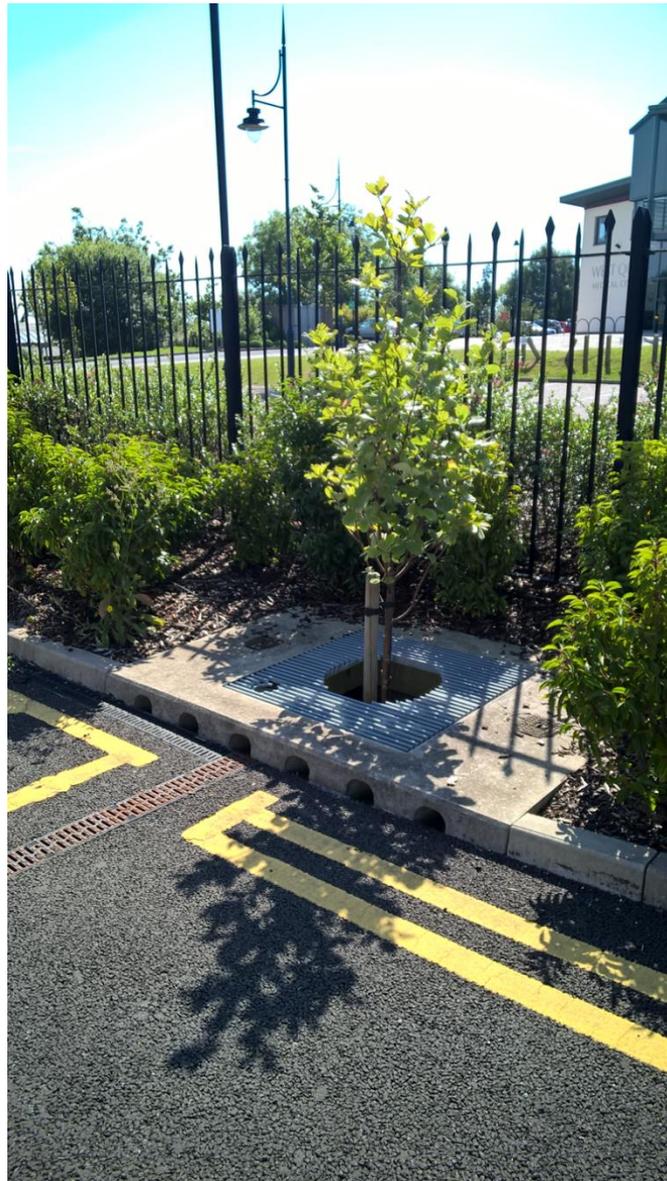
Fig 1: Biofilter unit with combined kerb inlet and channel drain inlet

Rain garden system is a self-contained unit that looks like a normal landscape feature from the surface, but contains a dual layer filtration system and effective inlet & outlet structures to accept and filter Stormwater runoff.

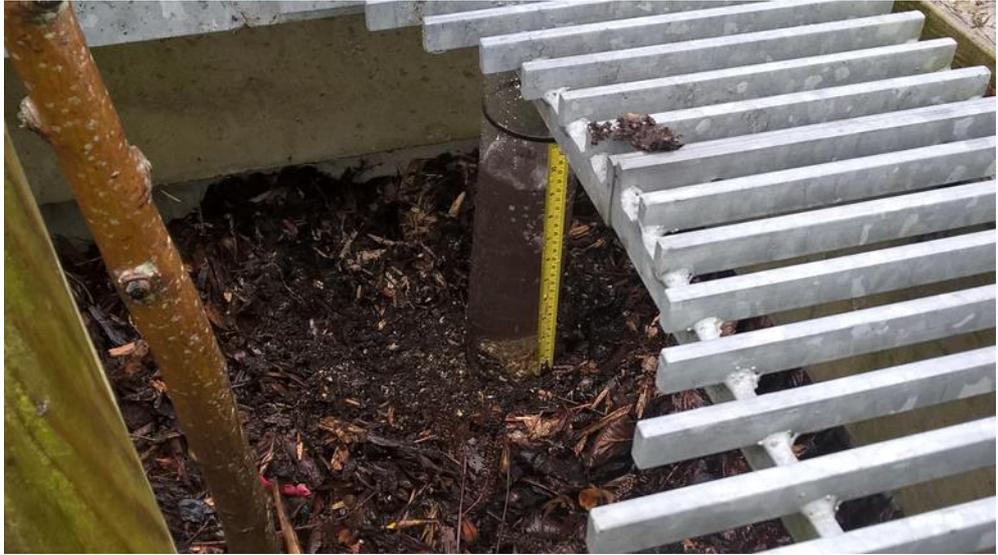
Fig2: Infiltrometer testing

A 2017 return visit by the manufacturer demonstrated that soil infiltration rates through the engineered soil have been maintained effectively by the ecosystem.

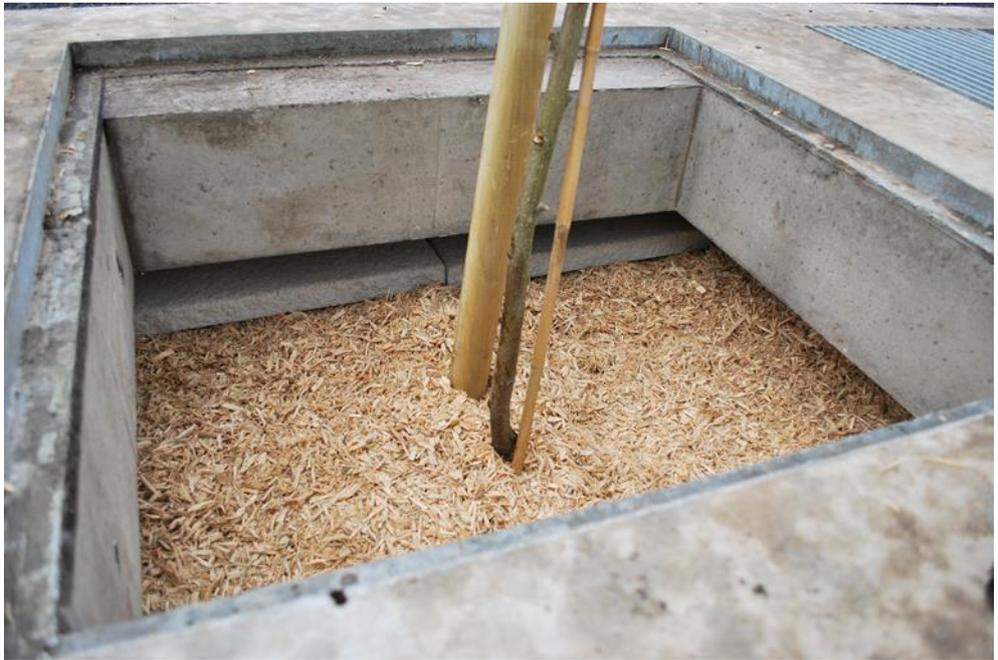
Fig 3: Installation of mulch layer

The manufacturer provided the first year of maintenance to ensure that the plant survives the transplant shock involved with being moved from a nursery into an urban environment and successfully takes to the new surroundings. The system requires an annual inspection and litter pick, along with removal and replacement of the mulch layer.
