# Victoria Park Health Centre, Leicester

## SuDS used

- “Biodiversity” roof
- Infiltration basin
- Wetland

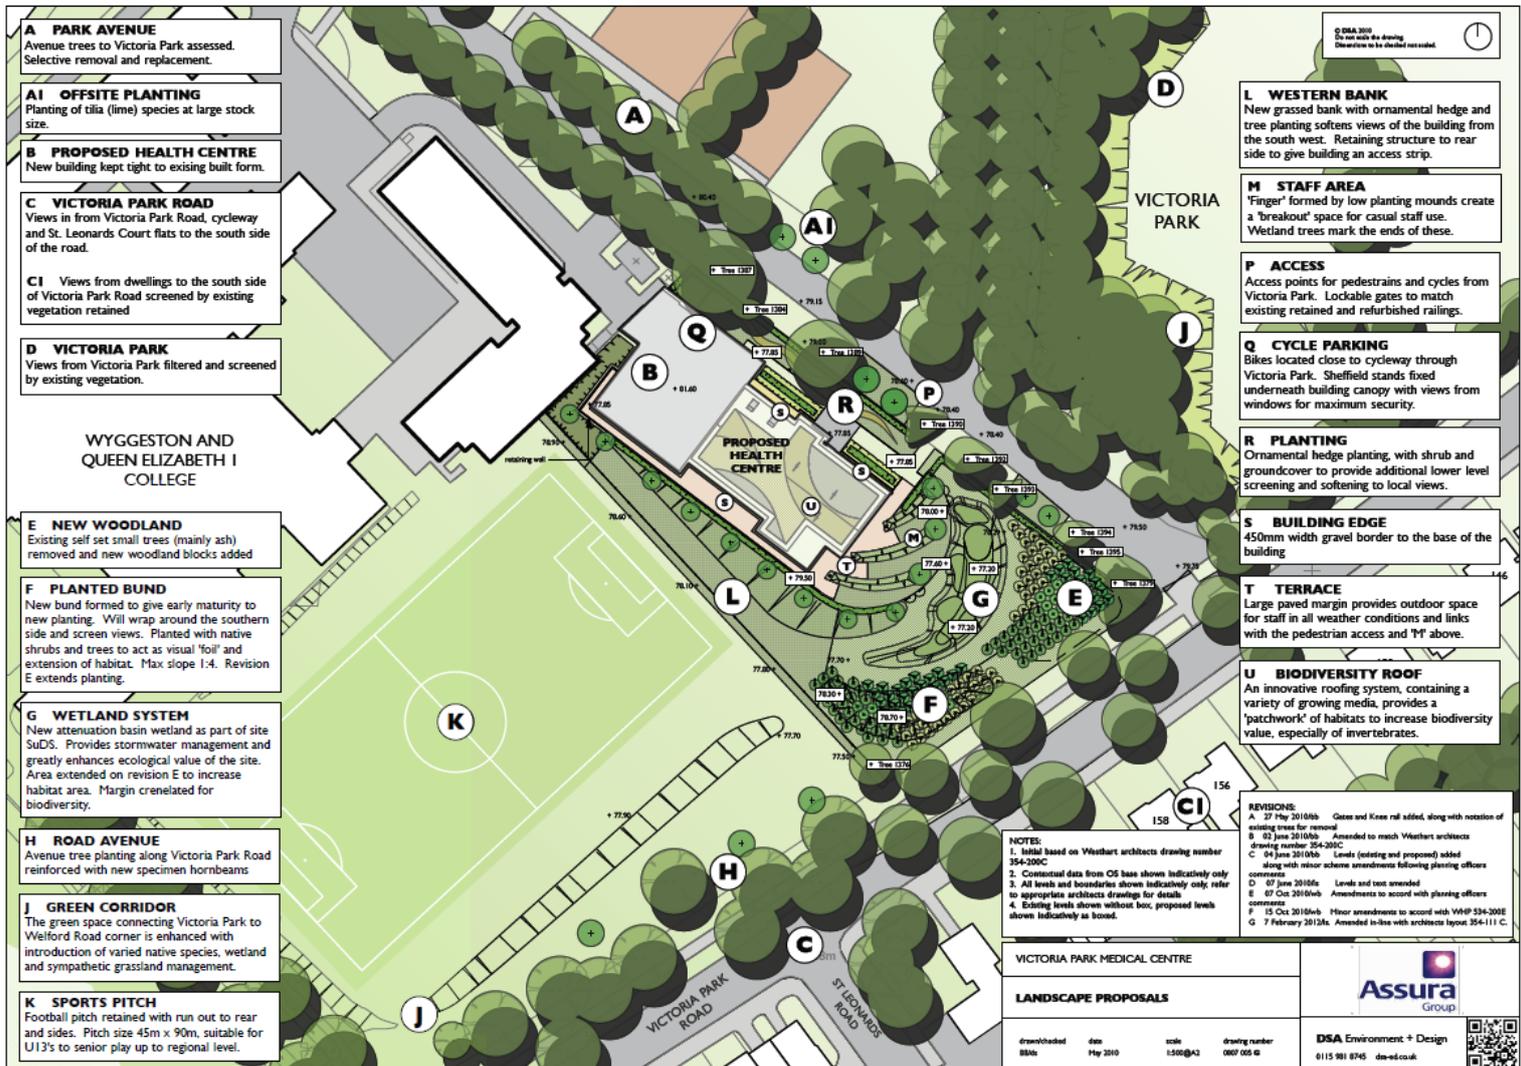
Figure 2 Landscape proposals

The Victoria Park Health Centre (VPHC) development is a two-storey health centre. The site is roughly 0.7 hectares in size and the site of a WW11 air raid shelter. Work began on the health centre in 2010 and was completed in winter 2013. The landscape design approach was intended to 'tie' the proposed scheme into its context and protect and enhance the landscape setting. The landscape design was developed in tandem with the architectural layout, to ensure that the proposal 'sits' comfortably within the existing landscape.

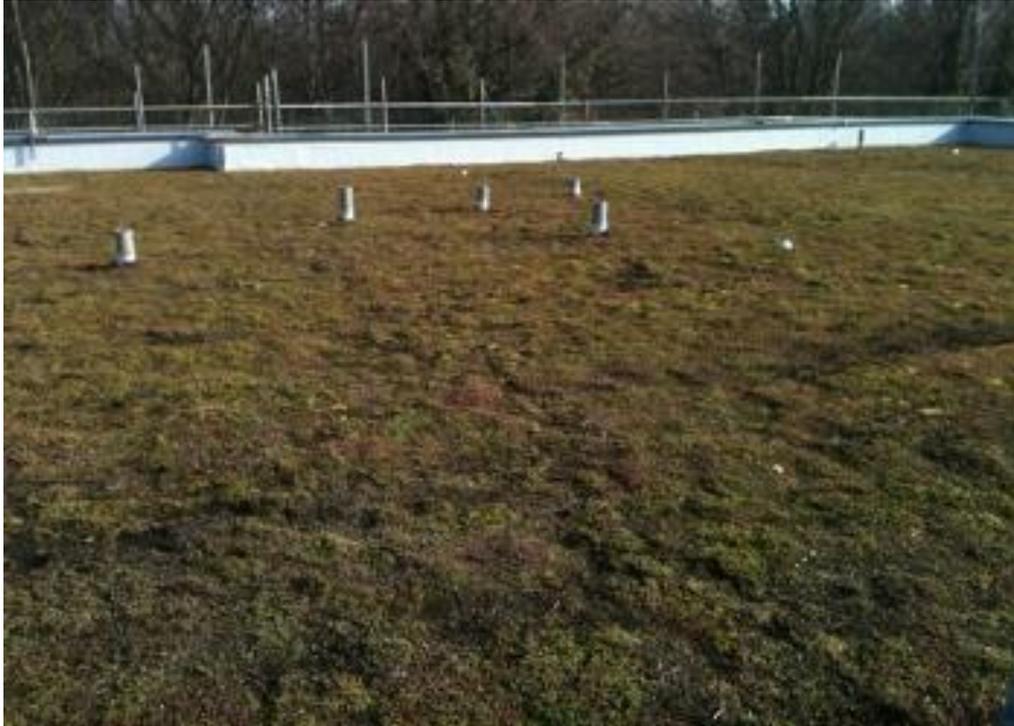
Figure 3 Biodiversity green roof. An all in one modular green roof system with an extensive sedum and lightweight soil-less wildflower mat laid over a 79-80mm substrate

The proposal to construct a two storey building in green space in the centre of Leicester demanded sensitive design. It became clear that dealing with the site’s water runoff would require an innovative approach. Early investigations revealed that percolation of water into the ground was a suitable option and so a SuDS scheme was developed, incorporating a ‘biodiversity’ roof and an infiltration basin.

Water from the building follows one of two routes. The car park run-off is piped into the marsh and treated there before being allowed to infiltrate into ground. This hasn't had any adverse impacts. The remainder of roof water falls onto the 'eco' roof. From there it runs down conventional rainwater pipes, into linear 'open' drainage channels and out into the marsh.

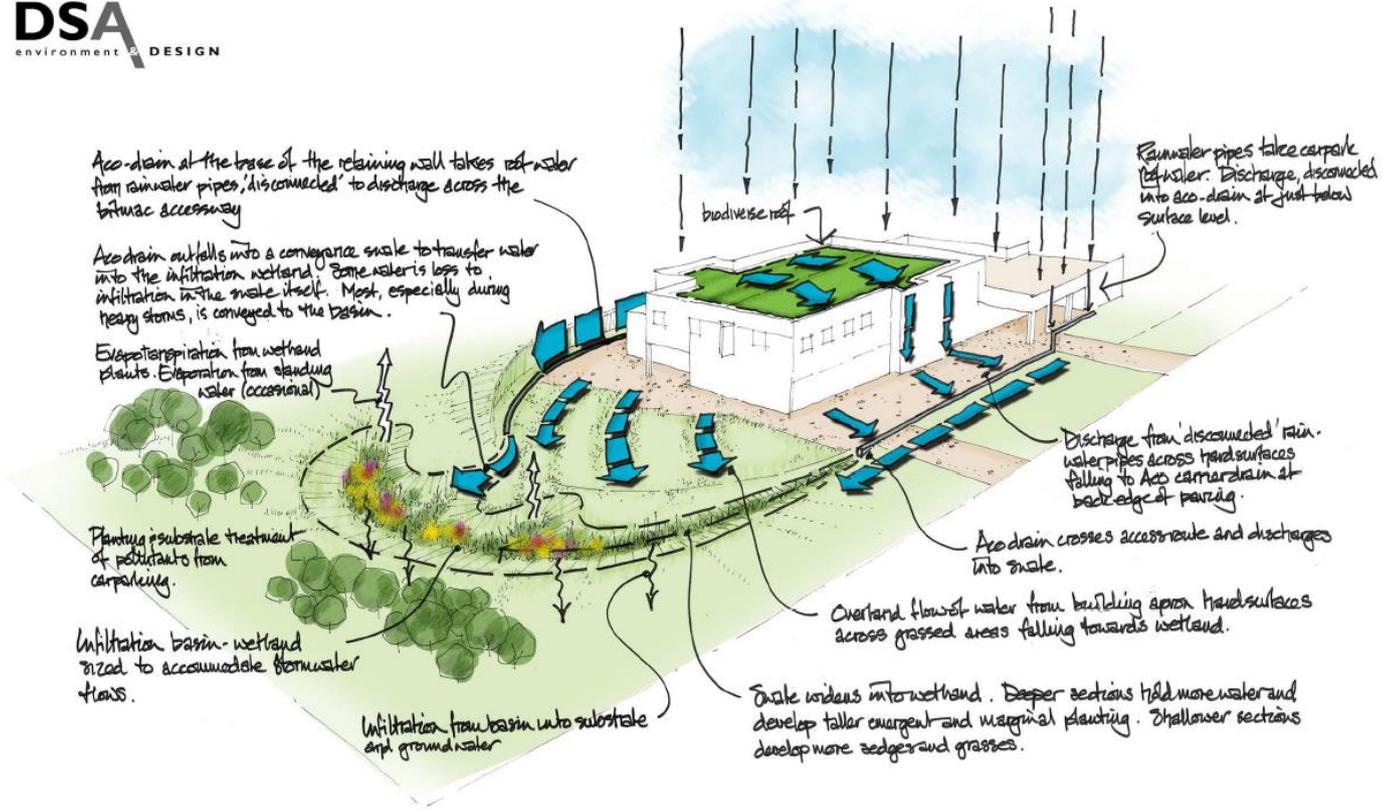
Figure 4 SuDS concept

**Sustainable Drainage System Concept**  
DSA Environment + Design Ltd  
dsa-ed.co.uk

Most water is conveyed to the basin, and filtered into substrate and ground water; however, it is also lost through evapotranspiration from wetland plants and from time to time standing water.

There is no 'discharge rate' as the system is designed to 'soak away'. No water flows offsite into the surrounding (road drainage) network. The system return period is designed for a 1 in 100 year event. There is no overflow/exceedance route and no flow control features are used. It's a relatively small site.

The feature is unlined to allow percolation of surface water into the ground. The wetland is planted with a range of species that treat the water naturally. Together with tree planting and wildflower grassland it introduces a greater range of habitats and ecological benefits than previously existed.

In order to explain the concept a computer model was created to show how the drainage would work.

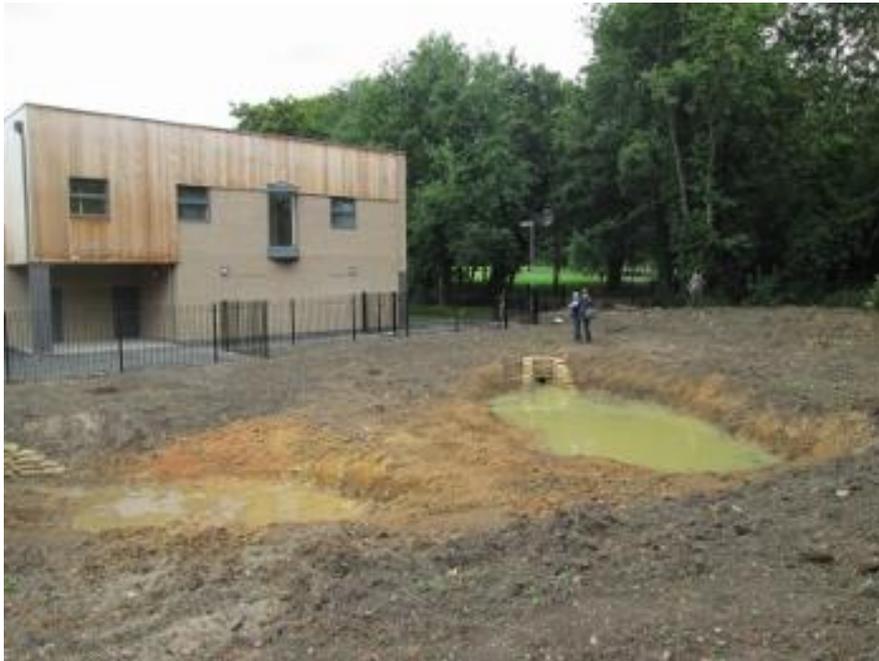
Figure 6 The infiltration basin during construction

number of treatment stages available for the car park runoff. Towards the end of the project the contractor made the gradients around the marshes too steep. It was necessary to meet on site and agree to form more gentle slopes. The site is subject to a landscape management plan (LMP). The contractors that installed the landscape are covering the 12 months maintenance of the site and DSA have been commissioned to produce an annual inspection and report.

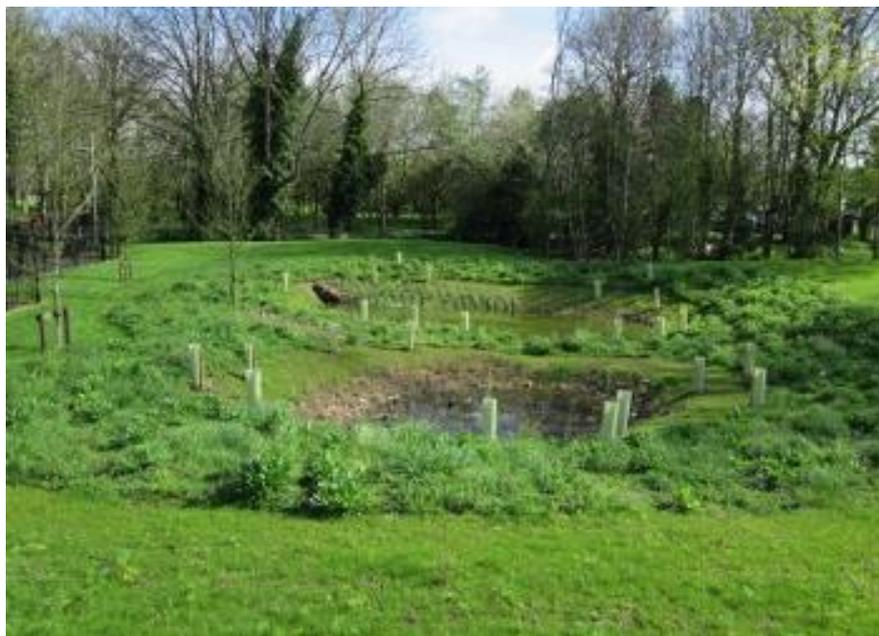
Figure 7 The infiltration basin with wildflower turf and grass seeding

It was envisaged that the wetland would not contain permanent water, since it would not be lined, but would function instead as 'marsh', drying out in warm weather. As such the basin has been planted with mixed marginal species such as reeds, sedges, rushes, yellow flag iris and purple loosestrife. The surrounding landscape has been carefully contoured and is seeded with a mixture of wetland grass and wildflower species such as stalked meadow grass, red clover and birdsfoot trefoil. Native trees were planted to provide a strong landscape framework.

It is anticipated that because the deeper sections of the basins hold more water, they will develop taller emergent and marginal planting, whilst the shallower sections and those that dry out more frequently will favour sedges and grasses.

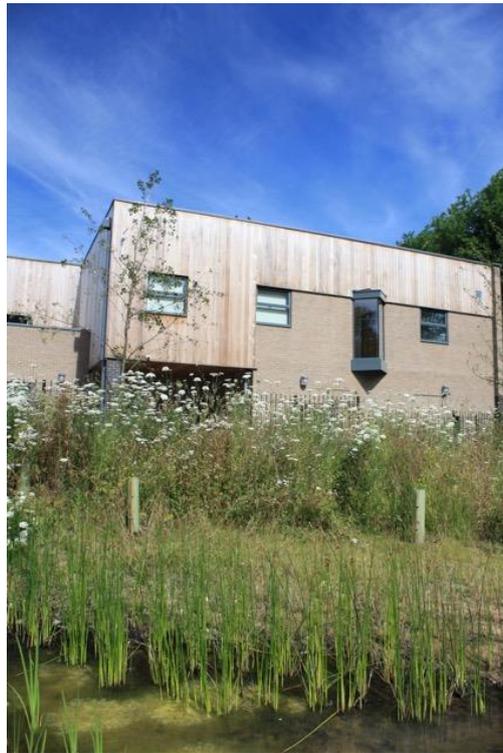
Figure 10 The Swales continuing to work well

The swales continue to work well to this day, with the DSA team regularly monitoring their performance. With much of the planting now established on site, a fantastic environment has been created for wildlife. The site attracts Honey bees and Broad Bodied Chaser.
