Castle Community Centre Rain Garden

2. Description

3. Main SuDS components used

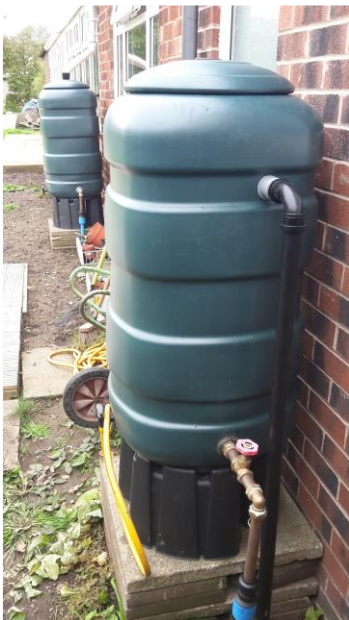
2. Water butts showing isolation valves and overflow pipe to raingarden

Three of the water butts are connected together by buried pipework and isolating valves, which enable these to be drained down individually or as a single unit providing a greater head of water and increased water pressure for use via hosepipes around the garden.

- A surveyors optical level and ranging pole were used to ensure that a fall of 1:100 was maintained along the length of the pipework to ensure sufficient flow to prevent siltation.
- Silt is also prevented from entering the system at the earliest stage as the waterbutts themselves act as effective silt traps, with water overflowing into the system only from the top of the waterbutt, while any silt will safely accumulate at the bottom.

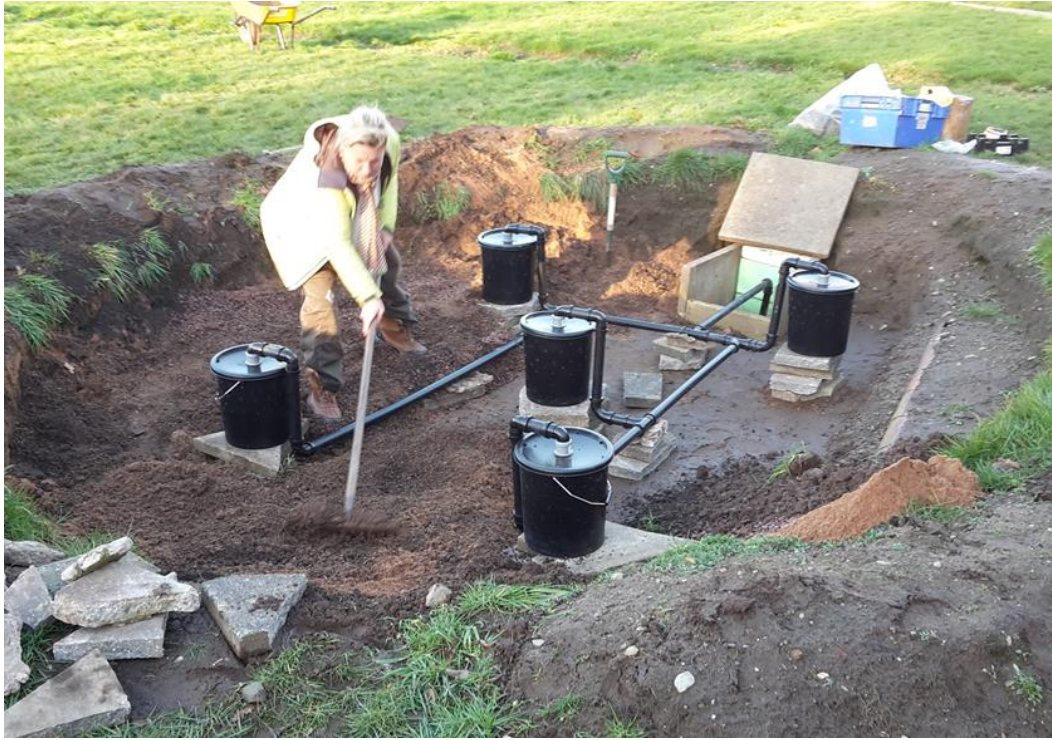
5. Love My River Volunteers installing five-point outfall and silt-trap buckets

- As it enters the raingarden, the pipe carrying rainwater from the waterbutts passes through an inspection chamber which allows for dismantling of the pipework at its lowest point, enabling flushing and de-silting if required.
- From this point the pipe divides into five branches, each branch having its own outfall. This also enables water to be more evenly distributed around the excavation. Each outfall empties into a bucket which has a series of drainage holes drilled into the sides of the buckets at regular spacings between the top and half way down. This enables any silt entering through either the outfall pipe or the drainage holes to settle at the bottom of the bucket.
- Before final back-filling, the buckets were wrapped with a geotextile material cable tied into place to reduce the likelihood of silt entering through the drainage holes.

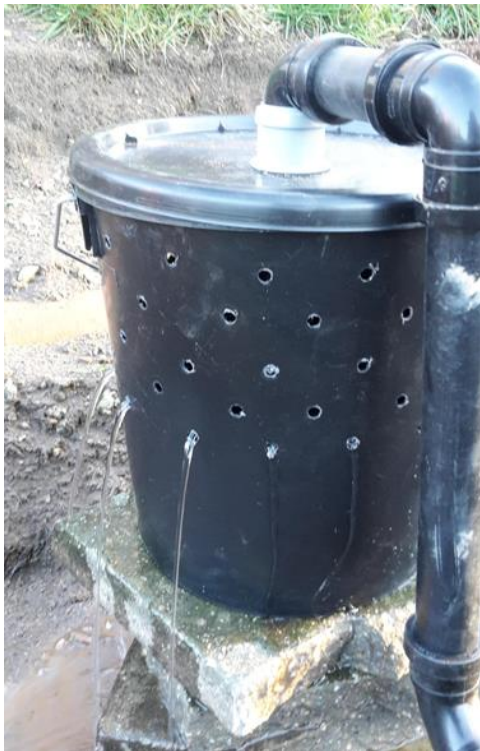
6. Testing silt-trap buckets being for water-flow
