Lamb Drove Sustainable Drainage Systems (SuDS) Monitoring Project

Final Report

Cambridgeshire County Council

March 2012
Final Report
9S7422

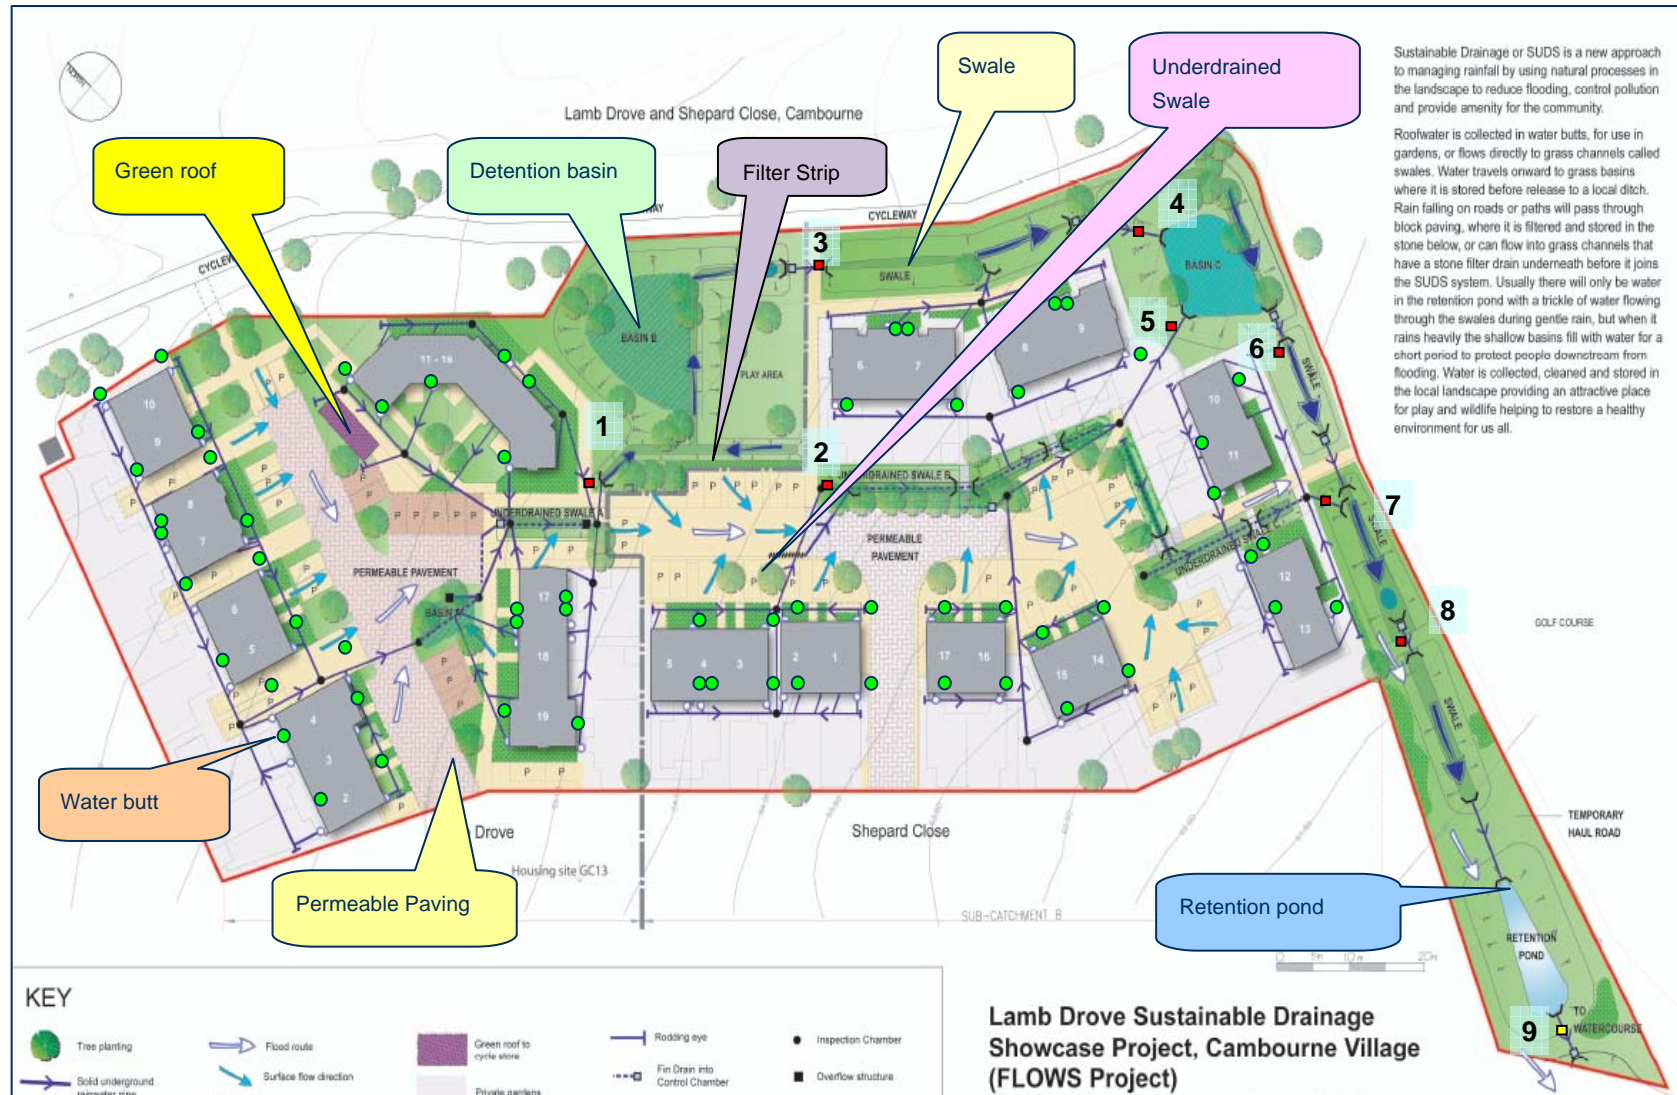
Figure 2.1: Monitoring locations at the Study Site

The discharge of water from the Study Site was monitored by a system of automated flow measurement instruments at eight monitoring locations across the site (Figure 2.1).

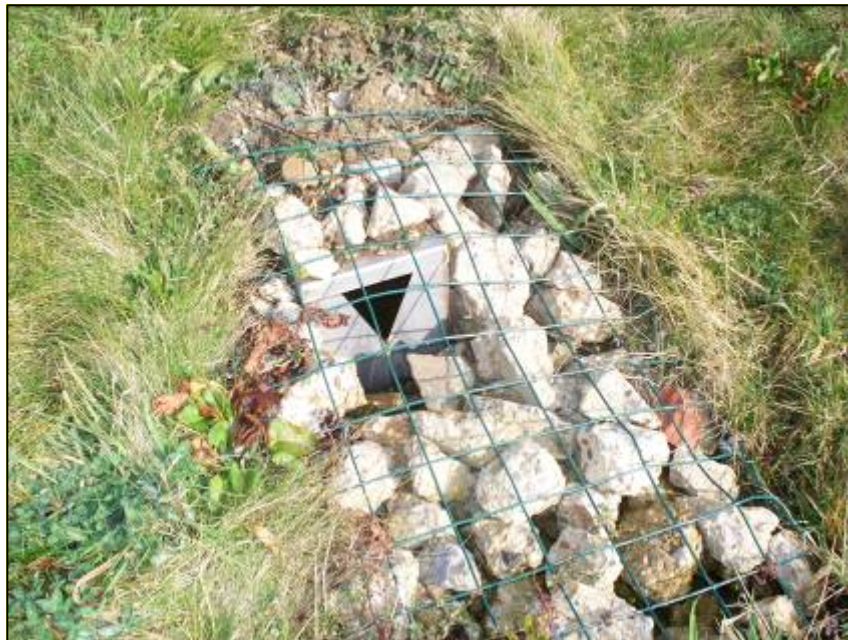
The flow measurement instruments were supplied by RS Hydro and consist of eight v-notch weir control structures constructed to BS 3680 with a standard $\frac{1}{4}$ vee (28°) notch (Figure 2.2). Within each chamber is a water pressure monitoring device, with an attached data logger that continuously records the water level flowing through the weir (Figure 2.1; Monitoring Locations 1 to 8). These have been downloaded on a quarterly basis as part of the monitoring regime.

Figure 2.2: V-notch weir control structure at the Study Site

The water level data has been converted to discharge (m^3/s and l/s/ha) using the standard equations from BS 1438 that replaced BS 3680 in 2008. The full sampling results are shown in Appendix B.

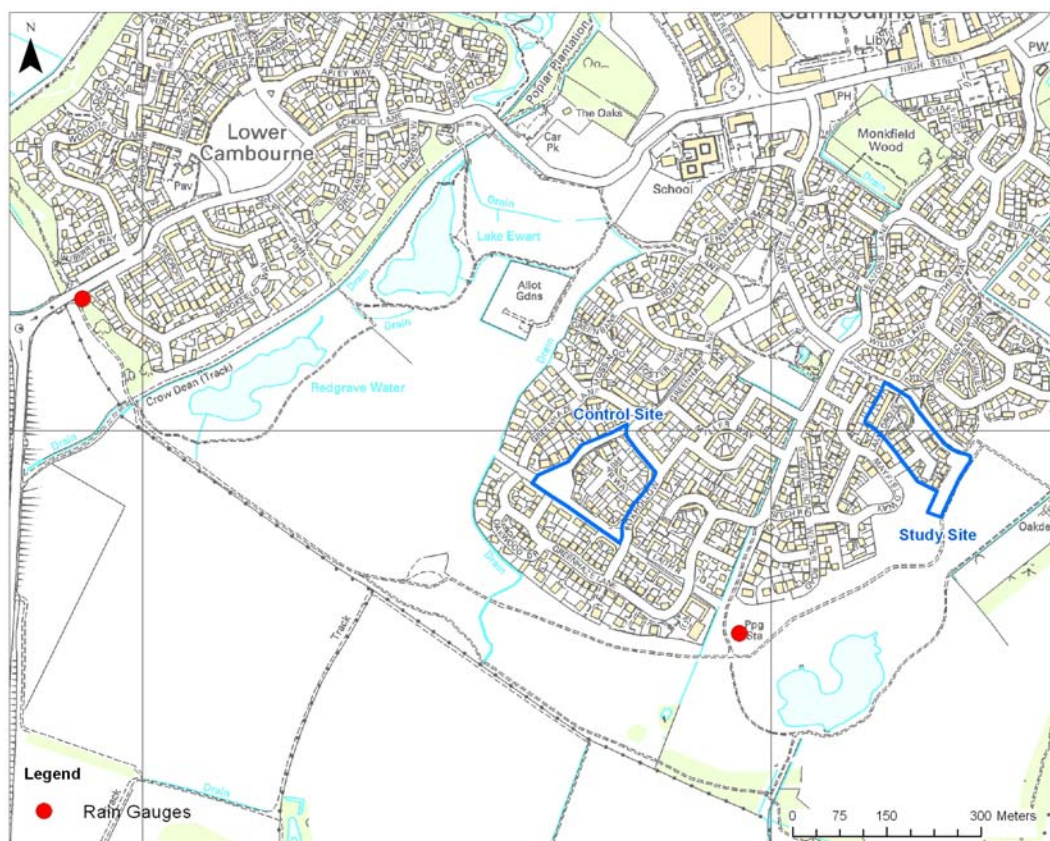
Continuous rainfall data has been collected using two tipping bucket rain gauges with data loggers located within the Cambourne development site. These have been downloaded on a quarterly basis as part of the monitoring regime. Figure 2.4 shows the location of these gauges. In addition data has been obtained from Anglian Water Services Ltd for a gauge installed in Great Cambourne between January 2011 and August 2011.

Figure 2.4: Location of Rain Gauges at Cambourne

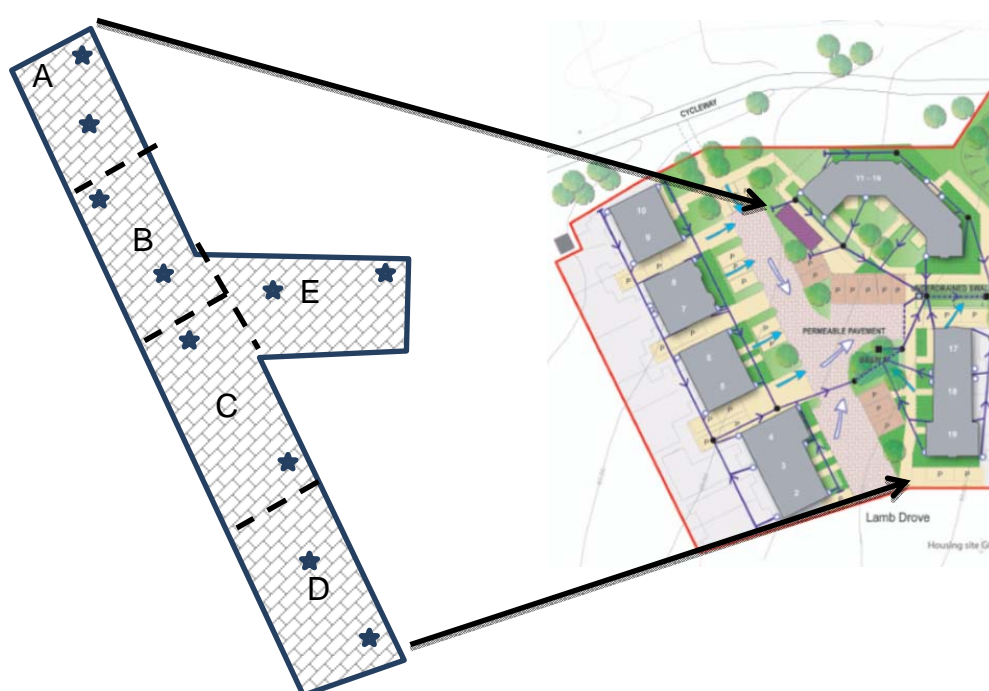
Cranfield University was commissioned to assess the hydrological performance of the permeable pavement at the Study Site and the impacts of this reduced maintenance. Infiltration capacity testing was undertaken during June and July 2011 and compared to the recorded rainfall events and rainfall intensities estimated to have a 1% and 2% chance of occurrence once every year, to assess the performance of the pavement. Manual cleaning of the pavement was also undertaken to investigate the impact of maintenance upon performance. Figure 2.5 shows the locations of the infiltration testing measurement points. The results of this analysis are summarised in Section 4.5.

Figure 2.5: The infiltration measurement points on the permeable pavement

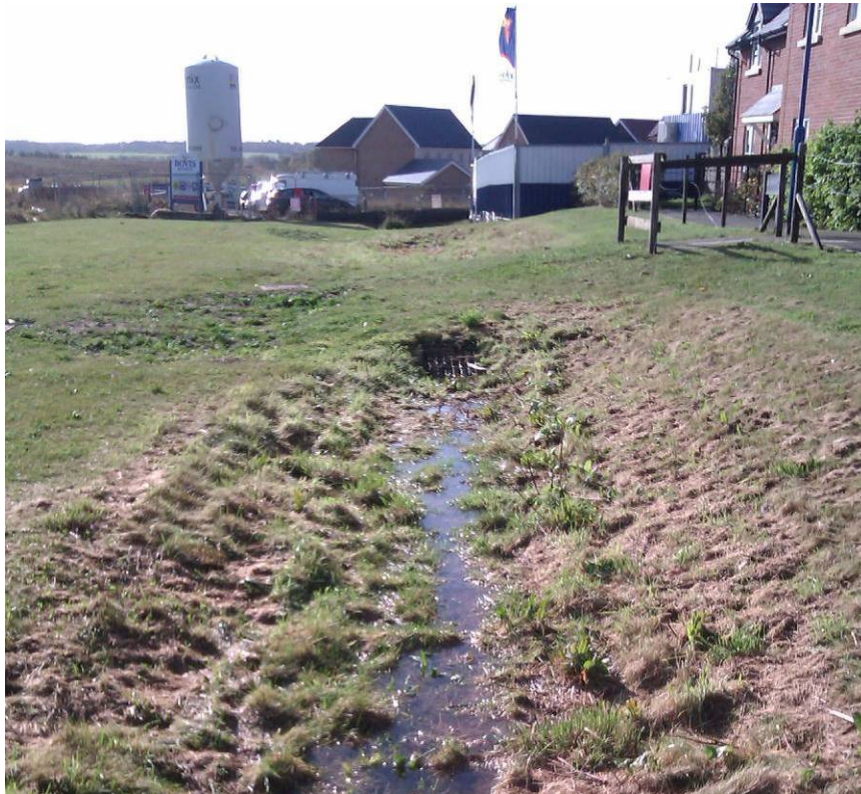
that the retention pond has been surrounded on three sides by the site car park, access road and eastern boundary of the construction site. This has prevented access to the pond for any maintenance and is likely to have acted as a sediment source. Cambridgeshire Housing Society has stated that their contractor has not been able to access the pond to carry out maintenance since 2009.

Figure 3.1: (a): Downstream end of the Study Site on 18th March 2011

Figure 3.1 (b): Downstream end of the Study Site on 19th May 2011

Figure 3.1 (c): Downstream end of the Study Site on 4th November 2011

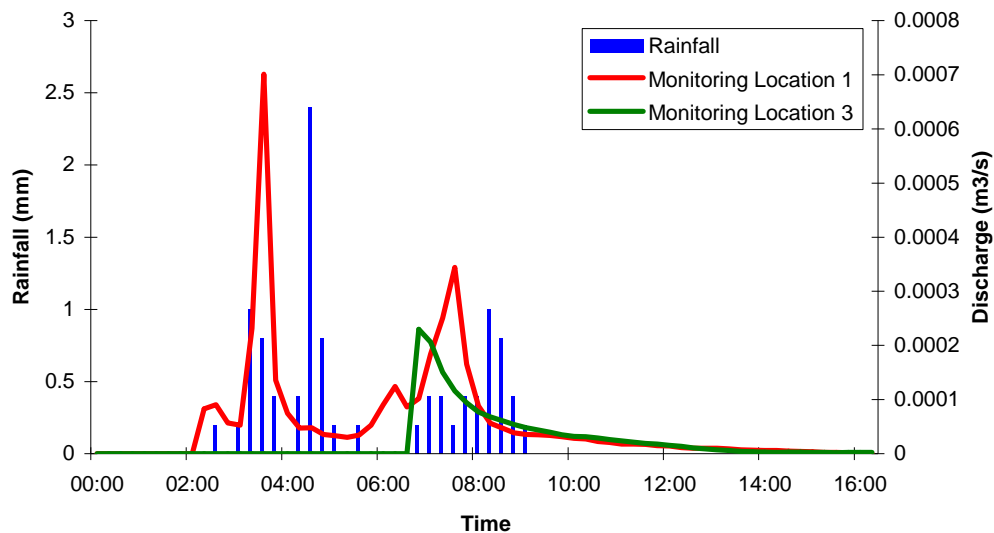
Figure 4.3(a): Rainfall and discharge at the Study Site on the 26th May 2009

Figure 4.3(a) shows how Monitoring Location 1 at the beginning of the system responds quickly to rainfall with the two peaks in discharge reflecting the peaks in rainfall. Monitoring Location 3 responded far slower in this event with a noticeable reduction in discharge. Monitoring Locations 4 and 8 did not register any discharge for this event.

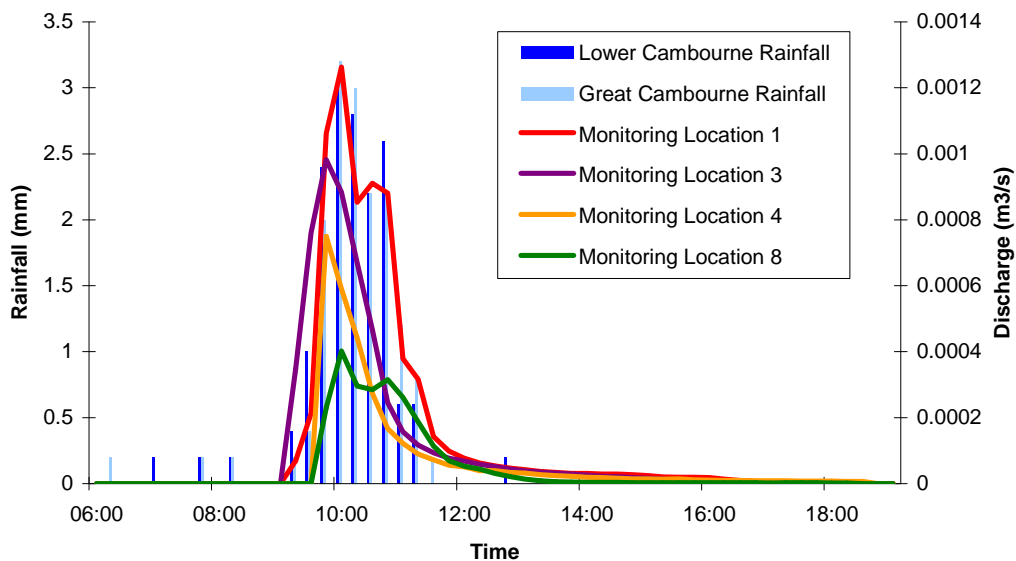
Figure 4.3(b): Rainfall and discharge at the Study Site on the 7th June 2009

Figure 4.3(b) shows how the system responded to a more intense rainfall event. The peak discharge recorded reduced through the site as more of the SuDS features within the treatment train were utilised, with Monitoring Location 1 recording far greater peak discharge than Monitoring Location 8. However, there was no significant delay in the timing of peak discharge between the sites and the discharge closely followed the pattern of rainfall.

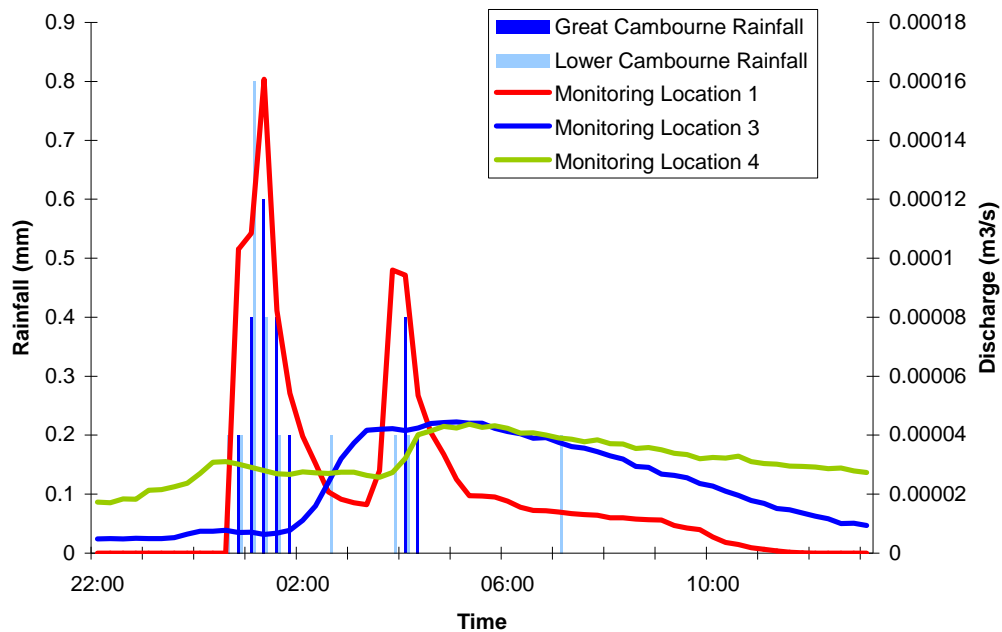
Figure 4.3(c): Rainfall and discharge at the Study Site on the 5th November 2009

Figure 4.3(c) once again shows that peak flow at Monitoring Location 1 closely follows the peak of the rainfall event, compared to Monitoring Locations 3 and 4 which observed reduced trends and greater lag times between peak rainfall and peak flows.

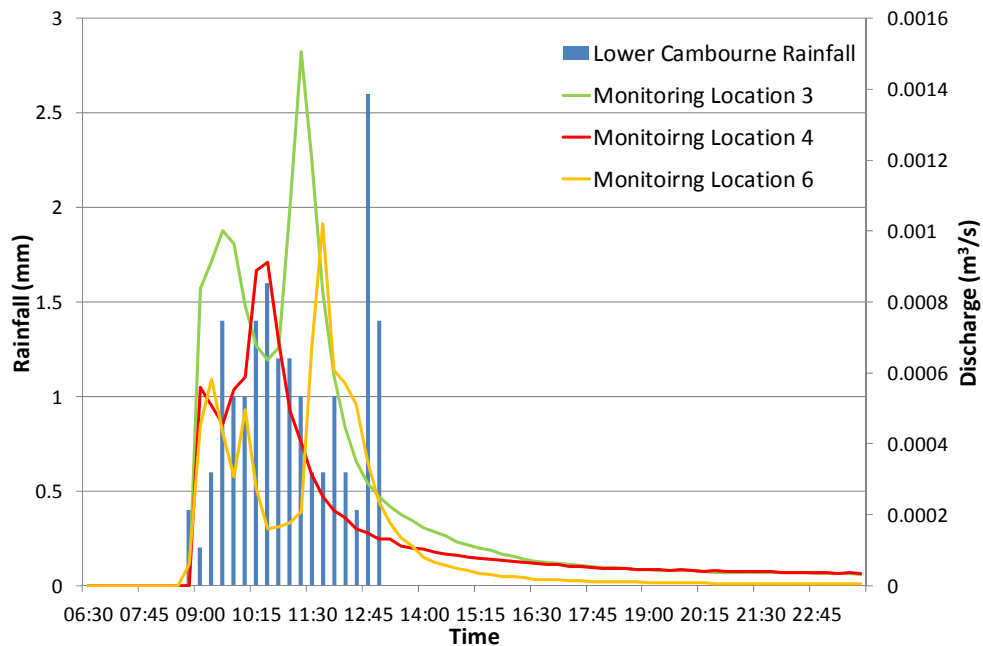
Figure 4.3(e): Discharge at the Study Site on the 16th July 2011

Figure 4.3(e) once again illustrates the effects of the SuDS system, by delaying the transfer of water through the system and reducing the impact of a rainfall event. The increased maximum discharge at monitoring location 6 in comparison to monitoring location 4 is likely to be caused by the additional that occurs upstream of monitoring location 6.

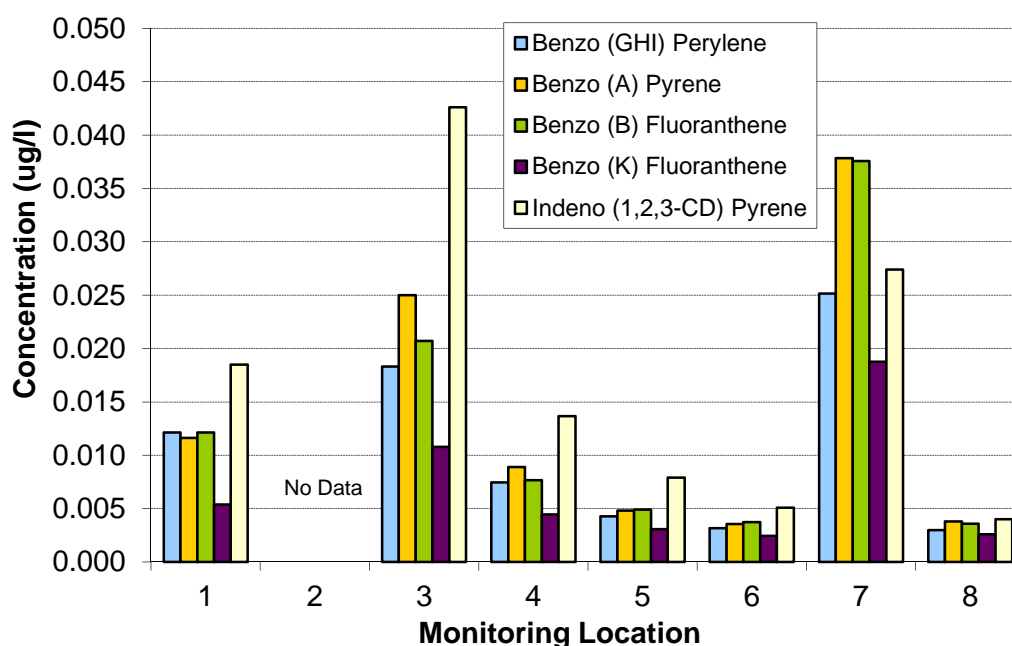
The concentration of the hydrocarbons tested for at the Study Site (Figure 4.9) follows the pattern observed with the TSS. This is the case as hydrocarbons attach themselves to fine particles through surface adsorption. MacKenzie and Hunter (1979) found that 86% of hydrocarbons were associated with particulates, and Hoffman *et al.* (1982) suggested this figure may be as high as 93%. This recognised correlation between TSS and hydrocarbons that is reflected in the results also explains the ability of SuDS to improve water quality. The SuDS features are designed to trap sediment, therefore the water leaving the SuDS feature should contain less sediment and therefore less hydrocarbon pollution.

The general trend in PAH concentrations can best be explained in the same way as with TSS. Monitoring Locations 3 and 7 give the highest concentrations and this is attributed to their proximity of the cycleway outside the site and the impermeable pathway within the site to Location 3 and the position of Location 7 within the context of the system. Overall the SuDS features appear to be causing a reduction in the concentration of hydrocarbons in discharge through the Study Site.

Figure 4.9: Concentration of Polycyclic Aromatic Hydrocarbons at the Study Site (2008-2011)

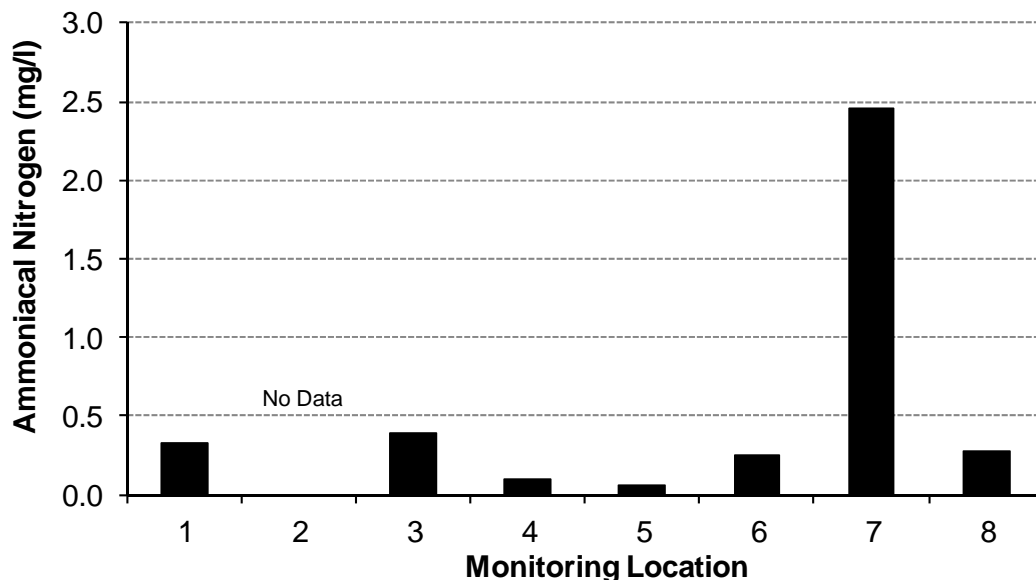
Ammonia levels are used as an indicator of organic pollution, and can be highly toxic to aquatic fauna (Foy *et al.* 2000). The results from the samples taken from the Study Site show a reduction in the concentration of ammonia through the SuDS system, except for the anomalously high levels at Monitoring Location 7 (Figure 4.14). This is likely to be due to the nature of the catchment for Monitoring Location 7.

Figure 4.14: Concentration of Ammonia at the Study Site (2008-2011)

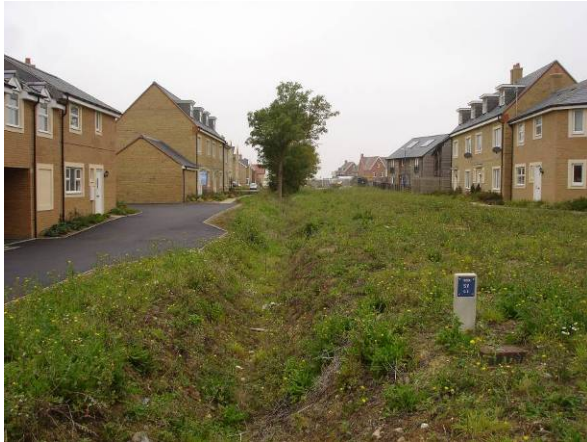
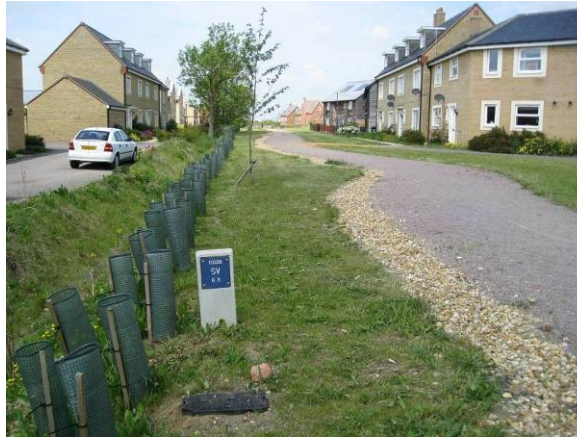
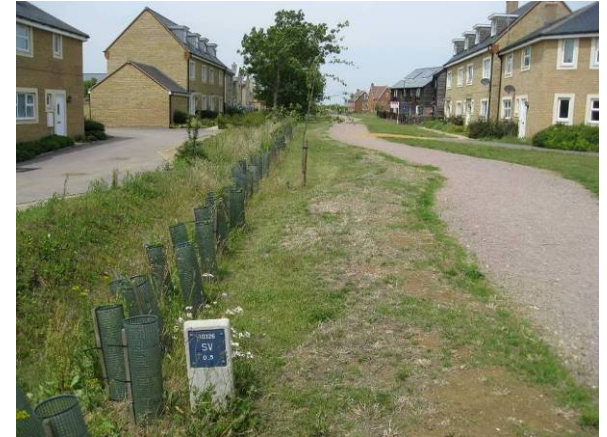
2007
Control Site
CS2

The photographic record illustrates the changes that have occurred to both sites between 2007 and 2011. CS and LD refer to Control Site and Study Site respectively.
