Junction 4, M8 Distribution Park

SuDS used

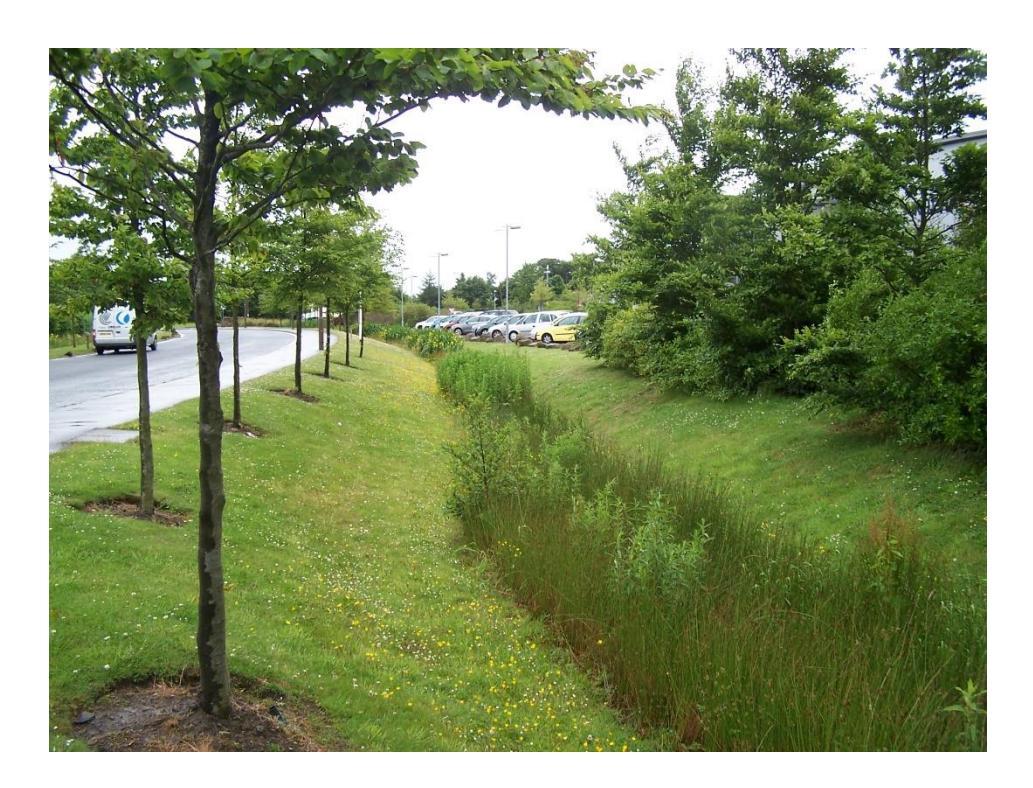
Ponds and basins serve individual plots which are large distribution and logistics depots. These then drain to a network of swales which in turn flow to a large regional pond, before discharge under the motorway to the River Almond – formerly Scotland's most polluted river.

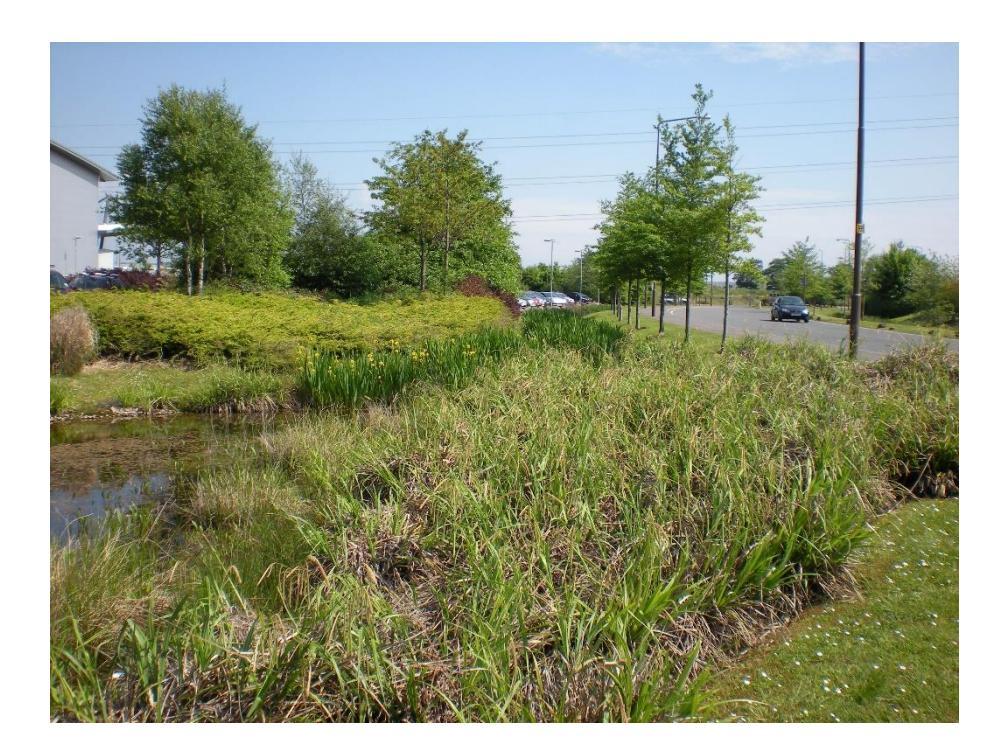
The swale network has delivered significant benefits through over 1 km of open channels that act to provide flood storage, excellent treatment and creates useful habitat to increase biodiversity across this, essentially industrial, landscape.

Ecology inspections have seen large amounts of frog spawn in the swale network and diverse flora including orchids. There is some evidence of water voles.

Occasional spills and vehicle washing have seen plumes of pollutants enter the swale network, but this does not reach far enough in to the swales or regional pond to cause harm to the eventual receptor of the water environment.

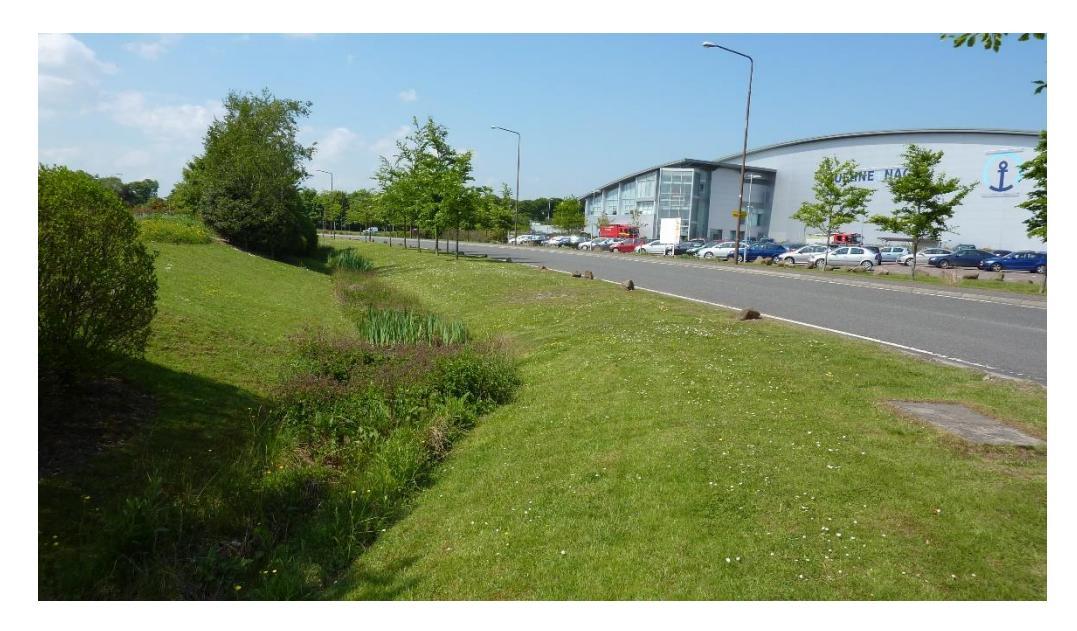
Vehicle management can be an issue when some HGVs cut corners and run over verges, damaging the appearance, although generally not the function of the roadside swales.

The "bulking-up" of vegetation especially in roadside swales had initially caused some ponding with verges being slightly higher than road surfaces. This is a lesson learned for future construction where the detail is to allow 25-50 mm drop below road surface at construction stage to let bulking-up of vegetation roots occur.
