Hollington Primary School, Hastings

SuDS used

2. Description

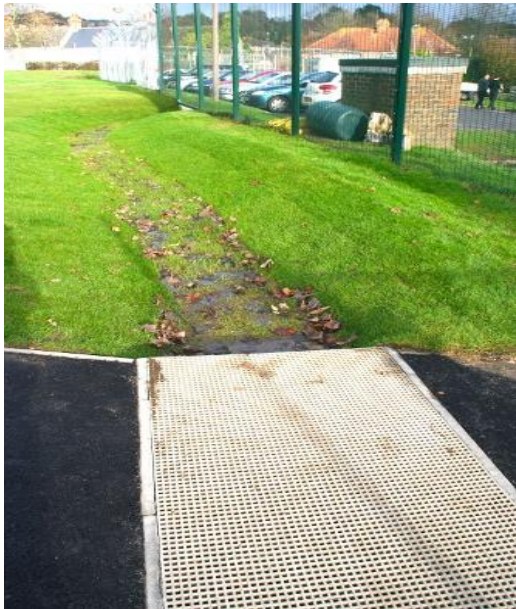
Figure 1 Bridge construction (before swale planting) allows shallow swale depth and grating surface intercepts path runoff

Existing topography demanded tight level tolerances and minimal inverts to features such as the swale bridge that has an invert of approx. 180mm from pavement surface level.

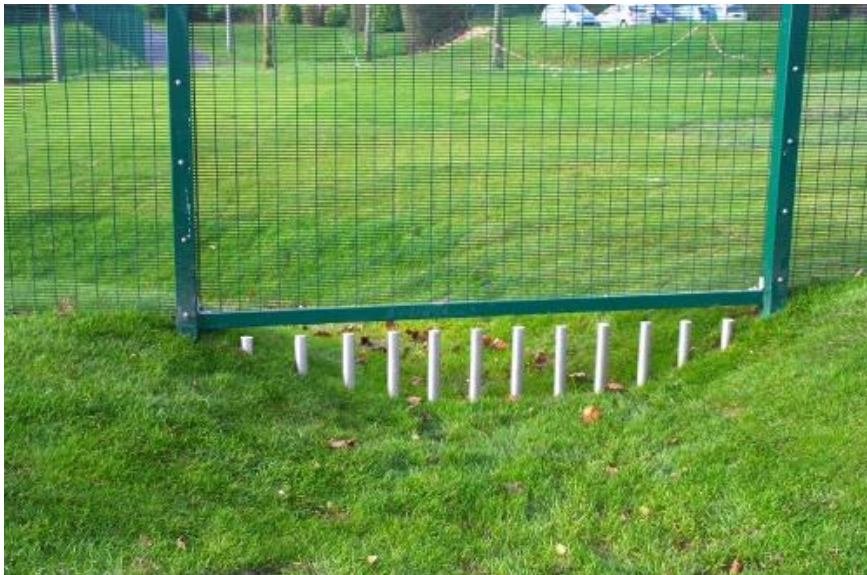
Figure 2 Stainless steel pins provide security at the site's secure boundary

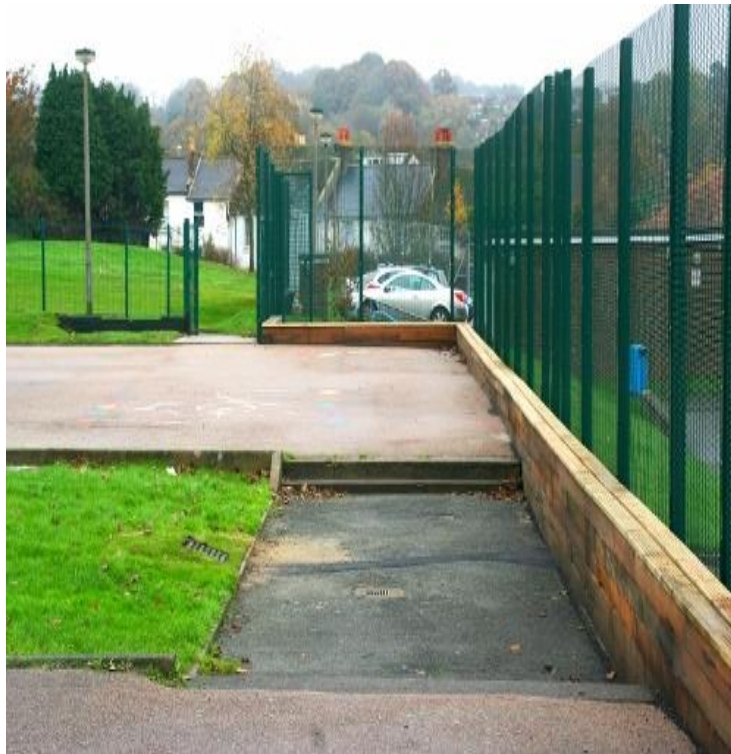
Figure 3 Timber seating wall converts an existing hard play area into a water large storage facility whilst providing added amenity for children

The main storage area is located within an existing hard play area. By creating a timber sleeper wall with sealant layers, along two sides of the play area, the play area can act as storage for larger storm events. For lower flows, a swale alongside the play area carries water toward a flow-controlled outlet. During larger storm events, as the storage area begins to fill, water will begin to pass through a slot weir and along a swale before being allowed to return to the sewer.

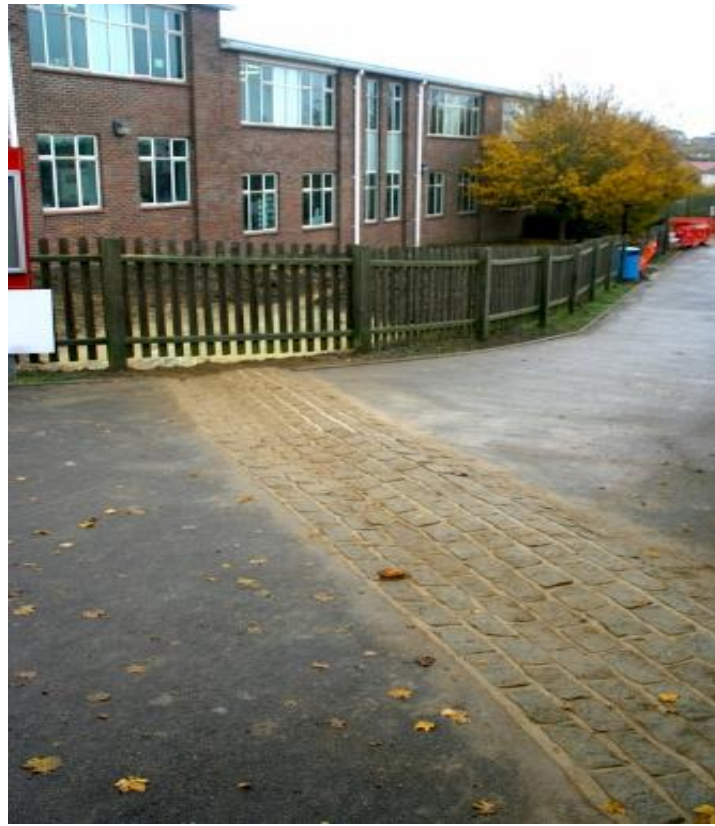
Figure 4 Granite sett flow diverter comprising combined channel and hump in a wave-like formation. The channel intercepts overland flow and diverts it to the raingarden basins beyond the fence (shown during construction)

Another point of entry for overland flow into the site is along a second pedestrian entrance to the school. Here the flow is diverted by means of a sine-wave sett channel and raised hump into two rain garden basins. One rain garden flows into the next and each collects rainwater from the adjacent school roof. The lower rain garden discharges into a piped outlet that re-emerges out of the wall of a second hard play area. A sett channel directs this flow, via a cascade, to flow out of this storage swale enters the sewer via an orifice flow control chamber.
