**2B's Office and House SuDS Retrofit
Submitted by 2B Landscape Consultancy Ltd**

**Awards category
Regeneration and retrofit – private properties**

Lead or collaborating organisation(s)	2B Landscape Consultancy Ltd
Location of SuDS	HU15 2LF

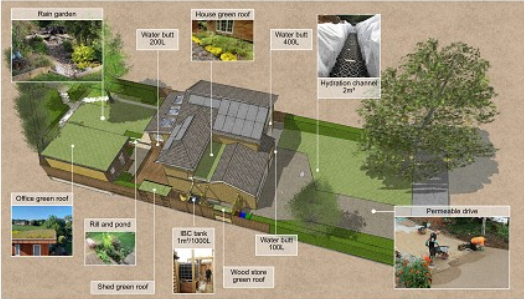
<p>Graphic locating all of the SuDS interventions; produced for 'North Cave Open Gardens', where Bill and Elizabeth opened the garden to showcase the possibilities to the neighbourhood.</p>	<p>2B Landscape Consultancy Ltd</p>

SuDS components used	<ul style="list-style-type: none"> • Four Green roofs: garage, wood store, shed and office • Water harvesting: four water butts including 1000L IBC tank • Permeable drive (KBI Flexistone) • Hydration channel / Rain garden to front garden • Rill and Pond act as conveyance from rear of house • Attenuation basin / rain garden to rear
Size of the scheme and its local context	Fairly standard 70's detached house/garden office and domestic landscape, in a rural East Yorkshire village. Total plot size approx. 0.1 hectares
Approximate age of scheme (years)	The scheme has developed over time – the oldest green roof is about 13 years old, the newest interventions are about 6 years old.
Benefits of the scheme	<ul style="list-style-type: none"> • Manages the water falling on the property • Adds biodiversity and interest • On-hand CPD for the 2B team - as Landscape Architects, living and working alongside SuDS features is a learning opportunity.

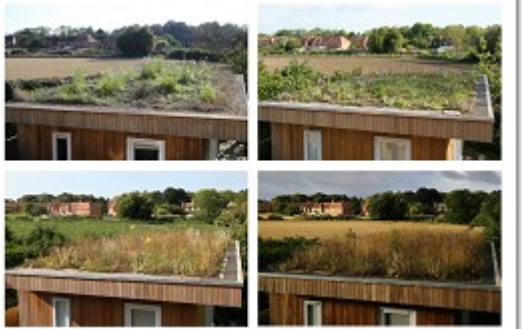
<p>The office green roof (36m²) over time, 2014-2018.</p> <p>No planting was undertaken on this green roof. A mix of garden soil and subsoil was retained and re-used from the office foundation excavation. This has led to some intriguing plant colonisation, from plants we knew we had, to many species that we had no idea were present in the soil seed bank. With only occasional weeding, the roof has provided a biodiverse and varied display every year.</p> <p>The office green roof results in a notable slowing of flow during and after a storm. The residual flow is directed to permeable 'Enviroflow', which links to the rear ditch, although the water is probably mostly absorbed by the surrounding soil.</p>	<p>2B Landscape Consultancy Ltd</p>

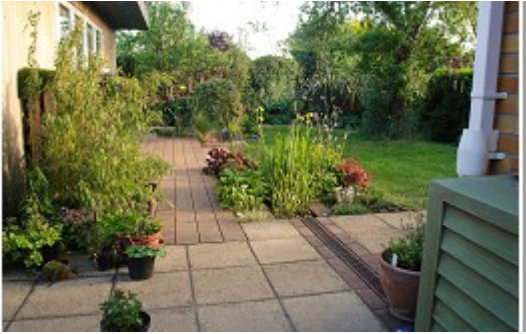
<p>The 200L water butt at the rear of the house (front right of photograph) flows, via a grated rill in the rear patio, into a pond which is made from a recycled bathtub. This is also fed by the IBC tank overflow, which is piped to the rear garden due to distance and gradient. The pond overflows into the rear rain garden, which is a shallow basin created in the rear lawn. When this basin overtops, it flows through a dry stream bed feature to the rear of the garden, where there is a ditch forming part of the local surface water drainage system.</p>	<p>2B Landscape Consultancy Ltd</p>

8	Is learning from the scheme continually captured and communicated? Please give examples.	The rear garden rill/pond/rain garden is adjacent the garden office, and has been monitored every time there has been a daytime storm. It performs faultlessly, and no water was seen in the rain garden basin until the serious rainfall and flooding event of November 2019, at which time there were a few inches of water and the overflow performed as expected. The front garden interventions have only been overwhelmed when forced to accept additional water from the adjacent lane, in a flood event. Learnings are communicated on 2B's blog .
9	What approaches/measures are taken to ensure the scheme is properly managed and maintained?	Maintenance is limited to normal garden maintenance, underlining the benefit of landscape-based SuDS – the level of maintenance specific to the SuDS features is negligible. It is limited to: <ul style="list-style-type: none"> • occasional weeding of the roofs; • checking and emptying of the Guttermate filters/diverters after heavy rain. These trap what would otherwise be a significant amount of organic material (moss, lichen and leaves) from the roofs, being deposited into the water butts and tank. These are all accessed at ground level, apart from the filter on top of the IBC tank, which needs a small ladder, but is easy to access.

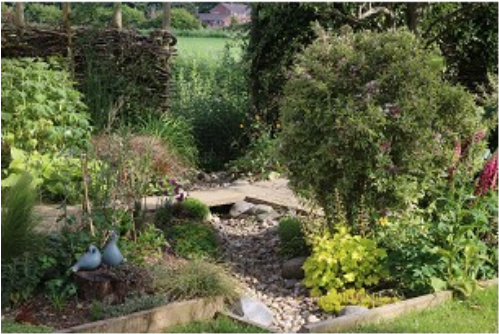
<p>When the shallow basin in the rear lawn overtops, it flows through a dry stream bed feature to the rear of the garden, where there is a ditch forming part of the local surface water drainage system.</p>	<p>2B Landscape Consultancy Ltd</p>

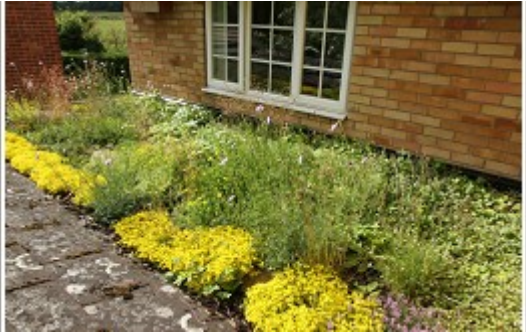
The house green roof: the flat garage roof was replaced with a green roof in 2010 (8.5m²), and provided a much improved view out of the window of the old office space in the house, until we were able to construct the garden office building. It also helps to regulate the temperature in the garage below.

The garage and office green roofs build-up comprise butyl liner and Terram protective membrane overlaid with recycled plastic permeable 'planks' (previously known as 'Aquadyne', now 'EnviroFlow') which provide support, protection and a drainage layer below the planting medium. In the case of the garage roof, and the shed and wood store green roofs, the planting medium was GreenTech GT-4 expanded aggregate, placed above a waterproofing liner. The garage green roof 'slows the flow' of part of the roof water destined for the IBC tank.

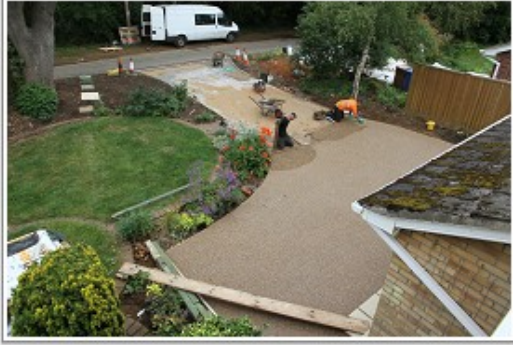
The permeable driveway under construction, with rain garden/hydration channel seen in the curved bed in the centre of the photograph.

The driveway was installed as the last major construction element, following the subsidence repairs and the office and rear extension construction. The former concrete drive (45 years old and well past its sell-by date) was removed for recycling. Type 3 stone sub-base was selected for its void content and permeability, and blinded with coarse sand.

The KBI Flexistone was laid to the sides of the house and the front, with simple timber edging, over the course of two days. The drive overlays part of the hydration channel, allowing a direct path for water into the channel. The channel is also fed from the front and side house downspouts, less the small amount diverted to the water butts.

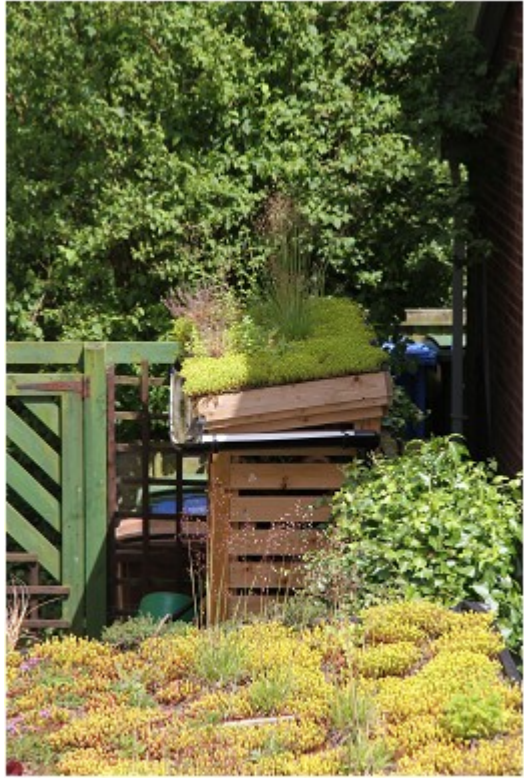
Micro green roofs on the wood store (1.1m²) and shed (3.8m²) were added in 2012, adding interest and biodiversity.
