Brockhurst Gate Retail Park, Gosport

SuDS used

1. Location

2. Description

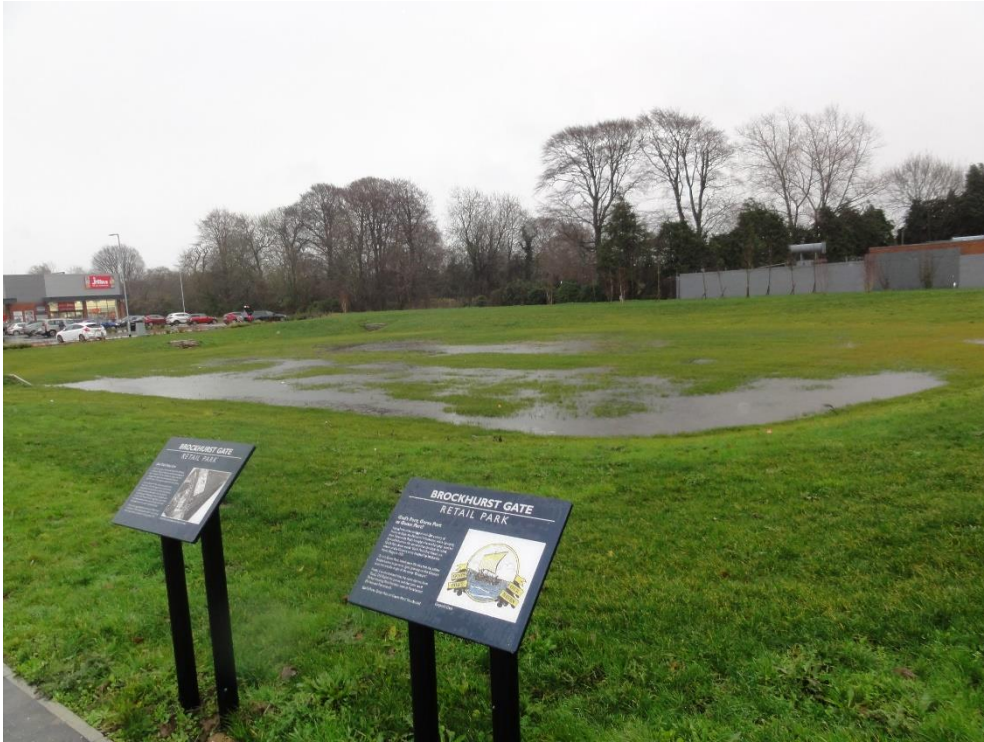
Swale 2

Fort Brockhurst is the other side of the woods which overlooks these 'fire fields'
The retail park is to the left and these information boards are at the entrance
To the retail park as you come off the buses, the raised footway that dissects the two
Swales as shown on the plan

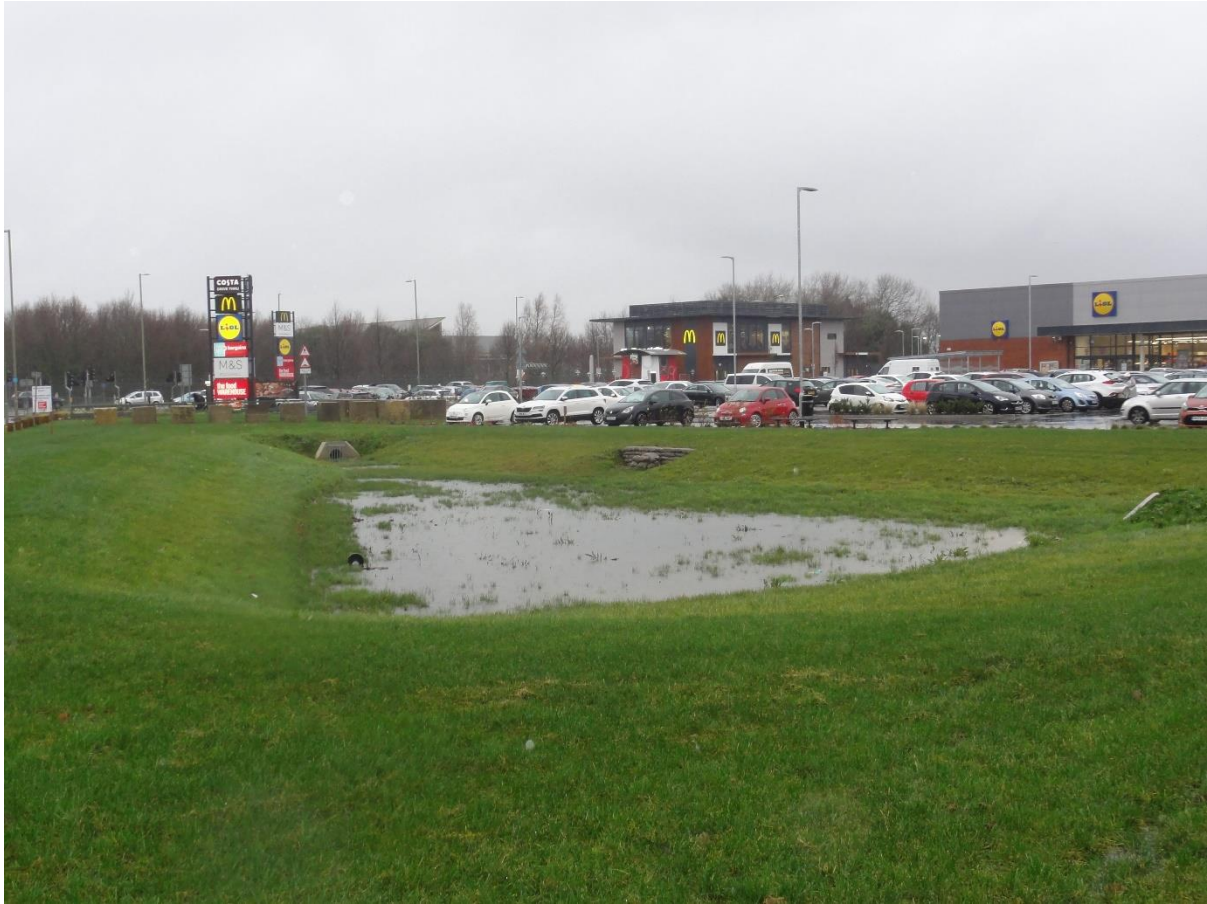
Swale 1

This view is standing on the raised path as per swale 2 but looking across swale 1. You can see the inlet at the far end where a weir exists that is exceeded when the water level reaches the crown of the 450mm pipe that runs down the left-hand side. Twin 450mm pipes extend towards the fast food outlet. In the middle is an outlet from the infiltration blanket underneath the car park that has porous blocks work car parking spaces. To the right is the link to Swale 2

Two flow control manholes have been designed that have weir walls such that during storm events typically in excess of 1:10yr occurrence, water overflows into the swales which are linked underneath a walkway through the middle. The flow control manhole at the discharge end prior to it connecting to the Public Sewer ensures that only the Greenfield rate of discharge is passed on to the sewerage network

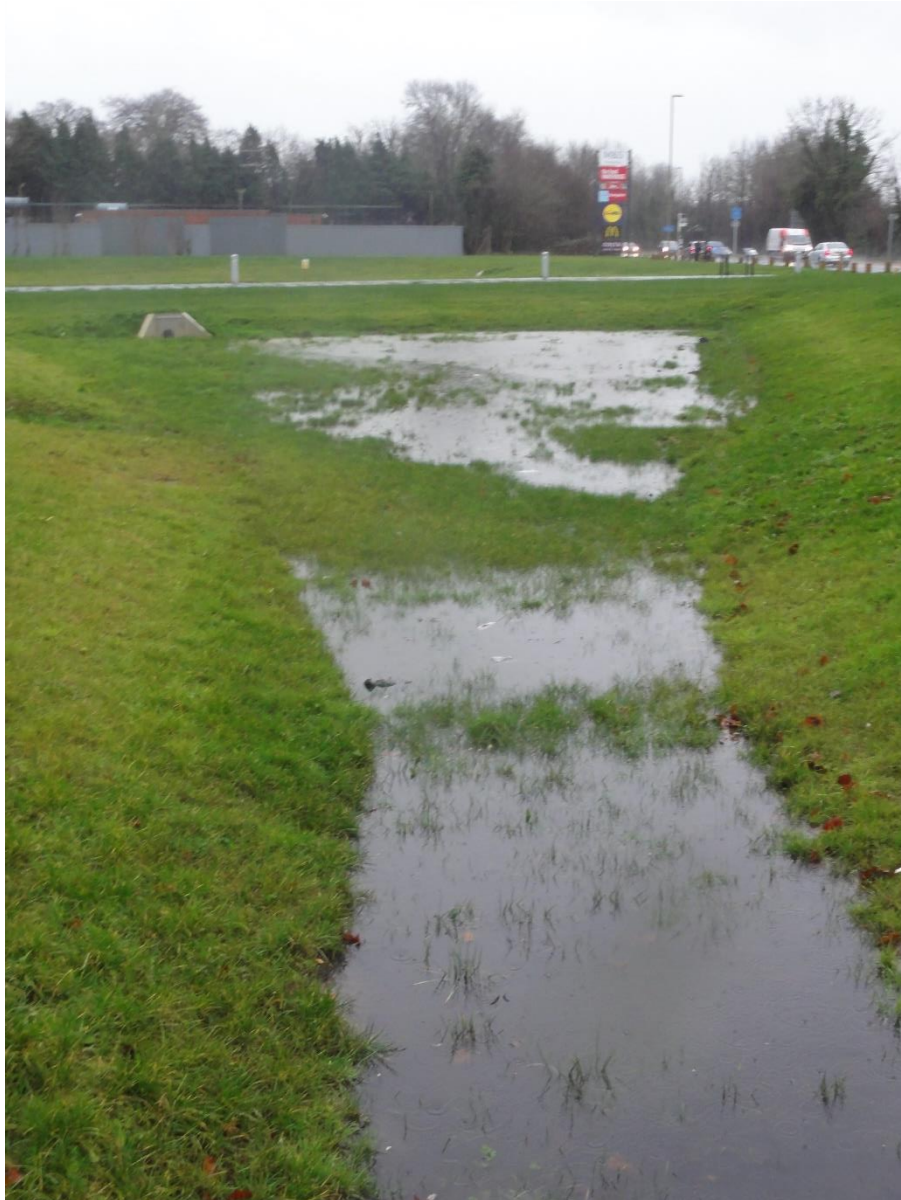
Swale 1

Looking back at the raised path and the link to Swale 2

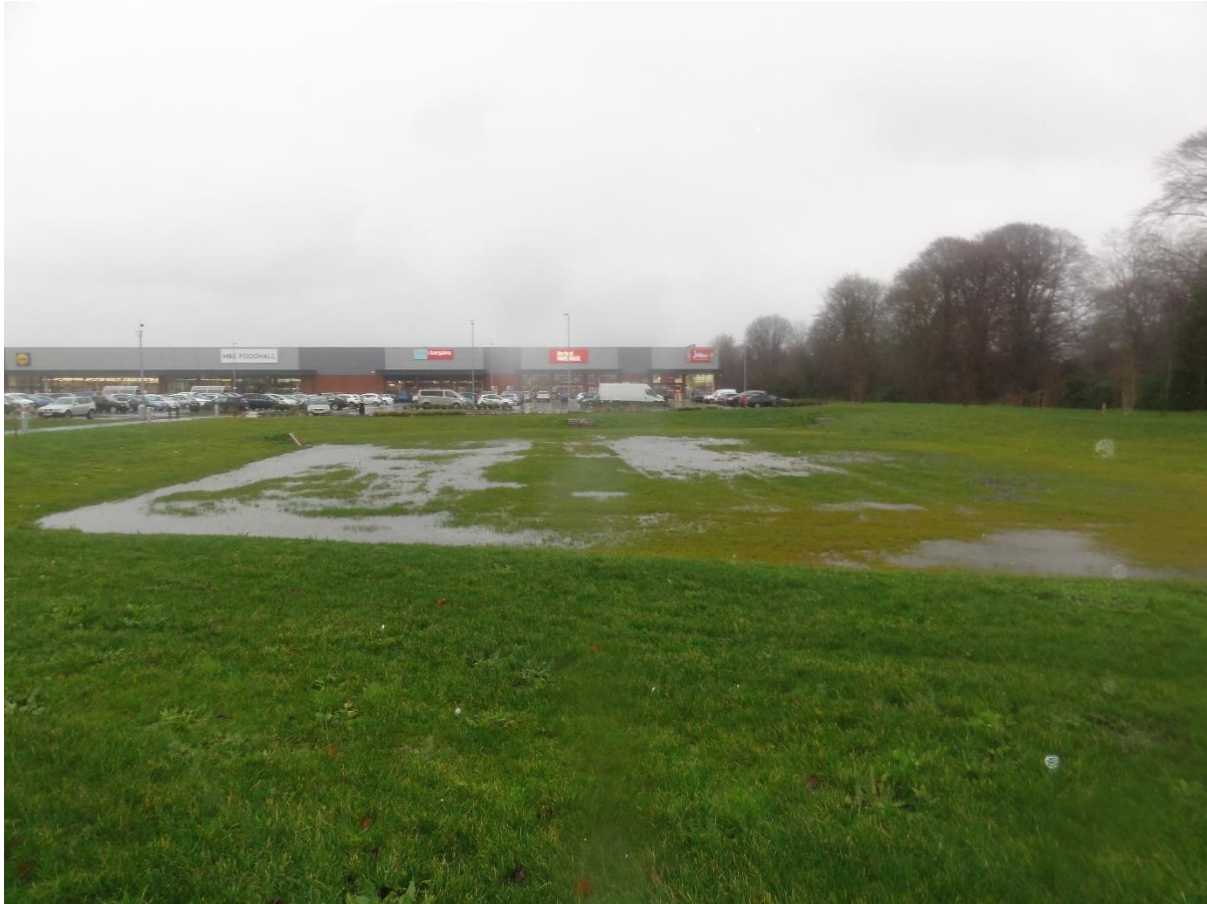
Swale 2

Link from Swale 1 to the left, overflow from the infiltration blanket central and another inlet from the right again a weir taking excess flows one the crown of the 450mm is reached
