# Markham Vale North, Derbyshire

## SuDS used

## 1. Location

## 2. Description

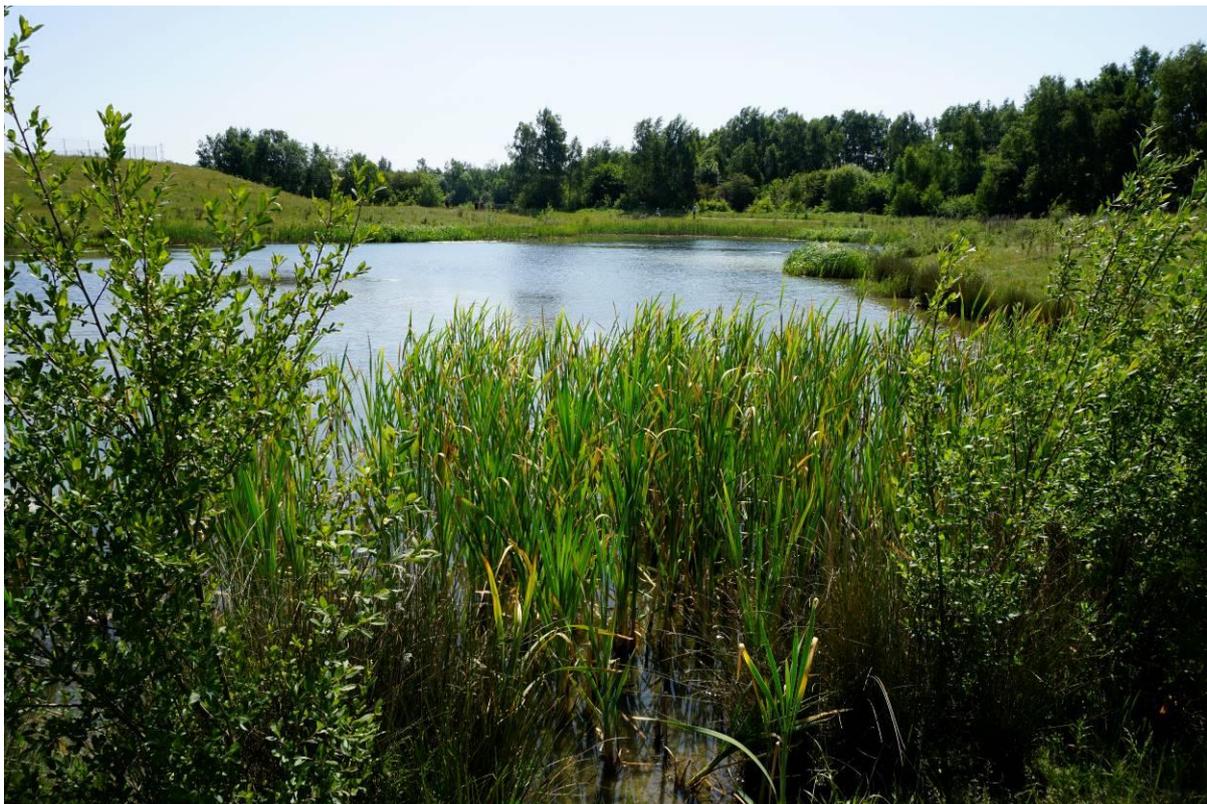
Fig 1 the largest pond in the Markham Vale North SuDs, designed to have permanent open water as well has storage capacity for a 100 + 30% flood event.

biological interaction. Some of the retention ponds are interconnected, three discharge directly into Hawke Brook. The discharge from each pond is controlled by a piped outfall set low enough to drain the pond to maximise its storage capacity in extreme rain events but at a height that will retain a level of static water for ecological and environmental benefits. The diameter of the pipes and their respective invert levels have been calculated to restrict the flow into Hawke Brook to 5 litre per second per hectare and the system has been designed to accommodate a 100 year +30% flood event.

Some of the ponds have been designed to have a relatively shallow permanent water level, the intention being that these ponds will become populated by reeds and rushes whereas others have been designed to have large areas of open water. This mix of ponds with differing water levels has been provided in the interest of developing a variety of habitats and increasing biodiversity within the site. A key design feature of the ponds are their bank gradients, wherever possible these have been designed to be as gentle as possible to maximise the transition area from water through wetland to grassland to provide diverse habitats and opportunities in which indigenous flora can populate and thrive. The gentle bank gradients are also visually pleasant and contribute significantly to the naturalistic appearance of the site.

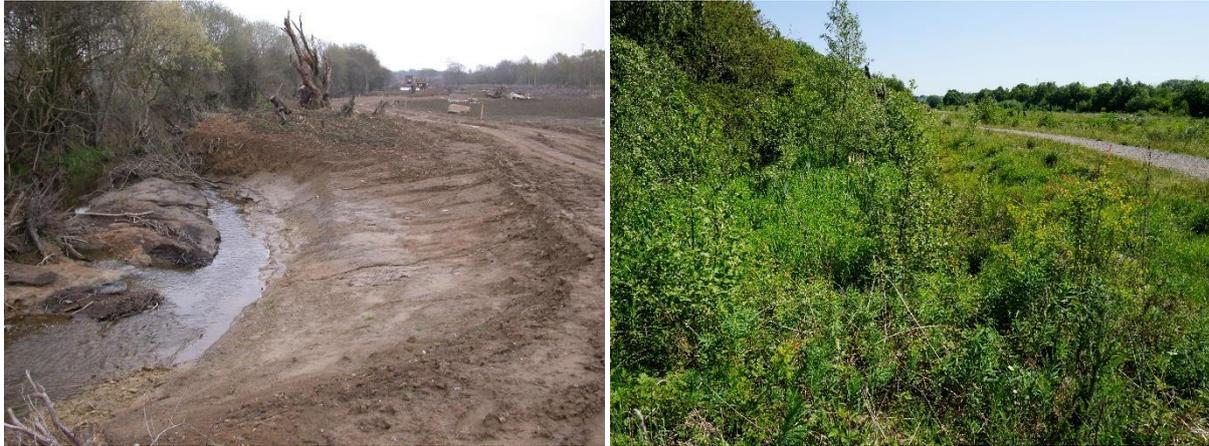
Fig 5 (left) 15<sup>th</sup> April 2016, illustrates the works undertaken to de-canalise Hawke Brook. On this section banks slopes were reduced, the width was increased and a second channel formed to accommodate flood waters and allow them to loose energy and deposit silts.

Fig 6 (right) 31<sup>st</sup> May 2020, shows the same view as shown in Fig 1 four years later. With the exception of the grasses all of the vegetation that can be seen within the second channel is the result of natural regeneration promoted by the de-canalisation and removal of overshadowing trees. The primary channel in which Hawke Brook runs remains as open, flowing water.

The de-canalisation of Hawke Brook has been something that officers working for the Environment Agency (EA) have suggested and requested since Derbyshire County Council purchased the site. The results of surveys undertaken on behalf of the EA had identified that Hawke Brook would benefit from improvements to biodiversity and water quality in line with the EU Water Framework Directive (WFD). The improvements that have been undertaken are visible by the diversity of flora that has established within the brook and along its banks. Small fish can be seen along its length which is a good indicator that the brook is in a good condition. The de-canalised banks now allow floodwater to overtop, lose energy and deposit silt as it passes over grassland. The vegetation that now grows on the stream bed and along the banks help to retain the stones of the streambed and also cause the deposition of silt which is assisting in maintaining and developing the streambed as a habitat.
