# Aztec West Business Park, South Gloucestershire

## SuDS used

- Retention ponds
- Detention basins

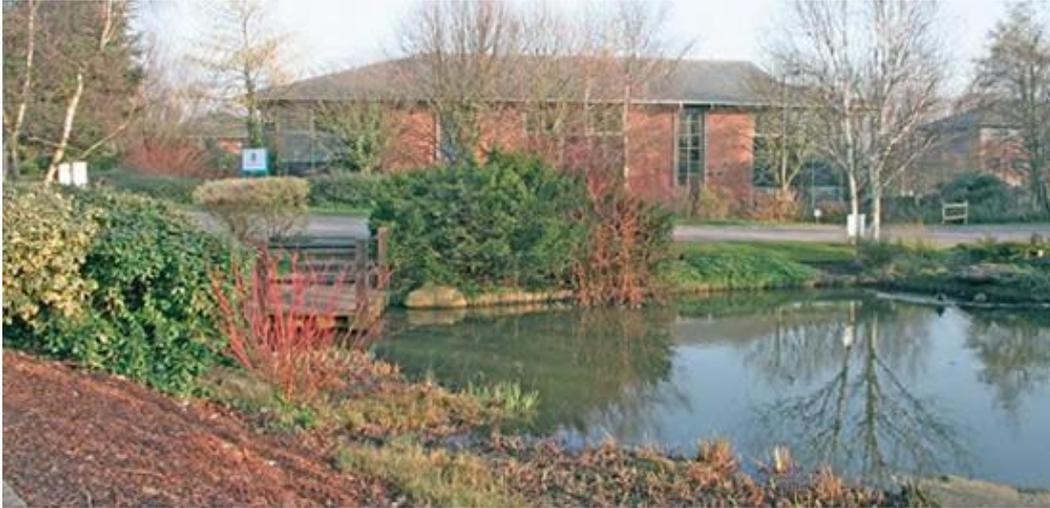
Figure 1 Aztec Business Park SuDS Scheme (1)

Retention ponds and detention basins, with fountains, to promote the aerobic degradation of hydrocarbons.

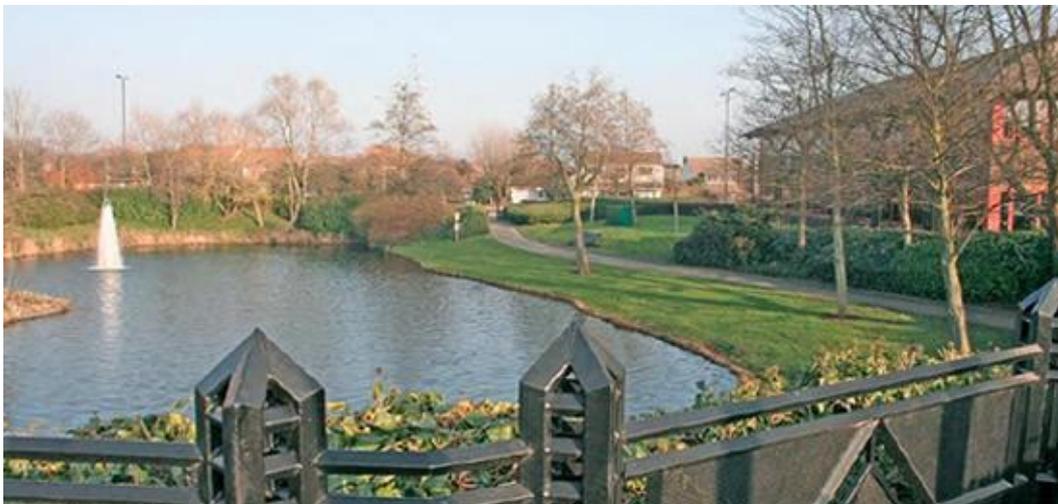
Figure 2 Aztec Business Park SuDS Scheme (2)

The local authority dictated a limited flow rate of site discharge. The client endorsed and encouraged this solution, whereby excess water is dealt with in a high quality, aesthetically pleasing way. The site has a series of ponds arranged in series, two retention ponds with permanent water and then a detention pond which remains dry most of the time.

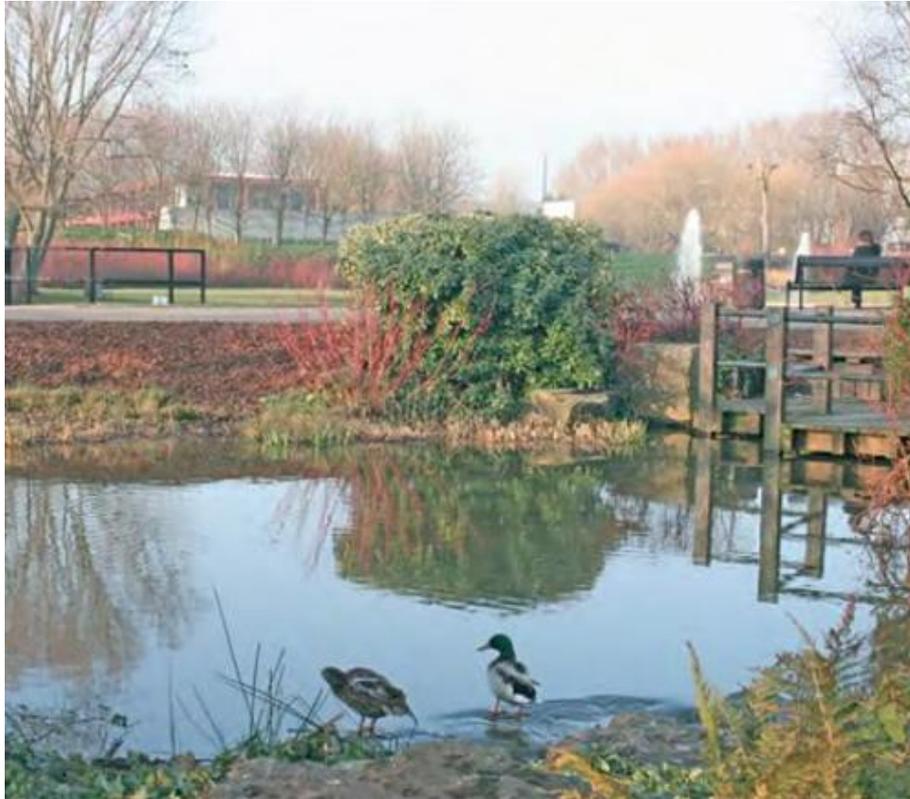
Figure 3 Aztec Business Park SuDS Scheme (3)

The large amenity ponds were fed from road and car park drainage. Instead of costly oil separators

to pre-treat runoff, large ornamental fountains were installed to aerate the water and promote breakdown of hydrocarbons.

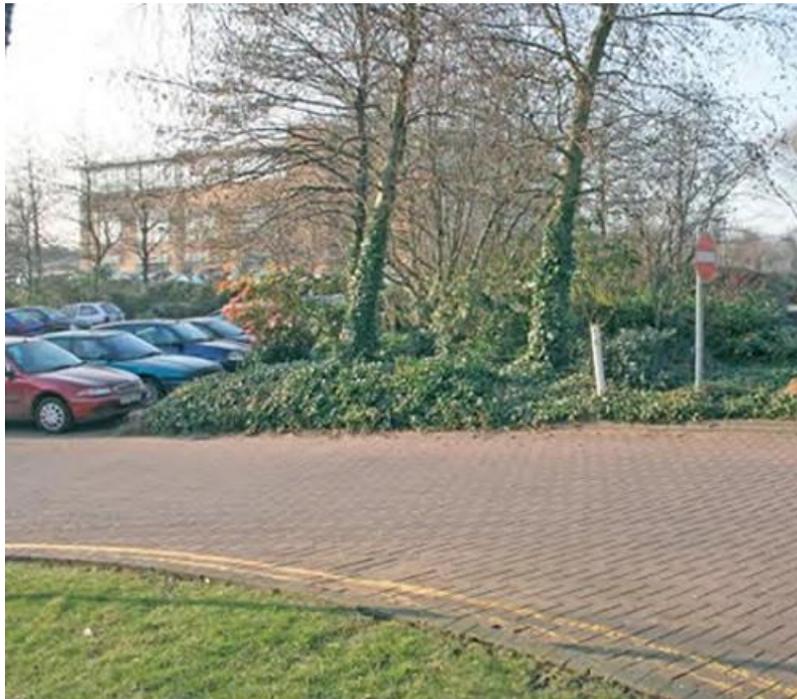
Figure 4 Aztec Business Park SuDS Scheme (4)

Consideration of infiltration trenches or stone-filled drains would now be given to supplement water treatment. Manholes were provided to allow for the retrofitting of oil interceptors, rockery inlets could have been otherwise provided to provide further aeration and aesthetic interest. The ponds could include a greater vegetated margin and accommodate more shallows and native vegetation.
