Hollington Primary School, Hastings

SuDS used

- Swales
- Rain gardens

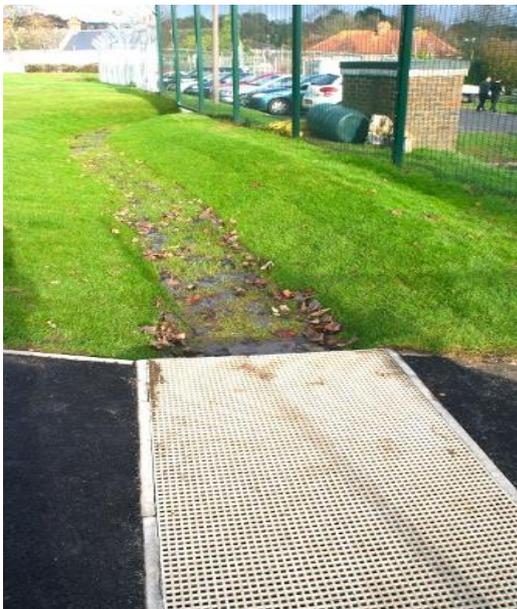
Figure 1 Bridge construction (before swale planting) allows shallow swale depth and grating surface intercepts path runoff

Existing topography demanded tight level tolerances and minimal inverts to features such as the swale bridge that has an invert of approx. 180mm from pavement surface level.

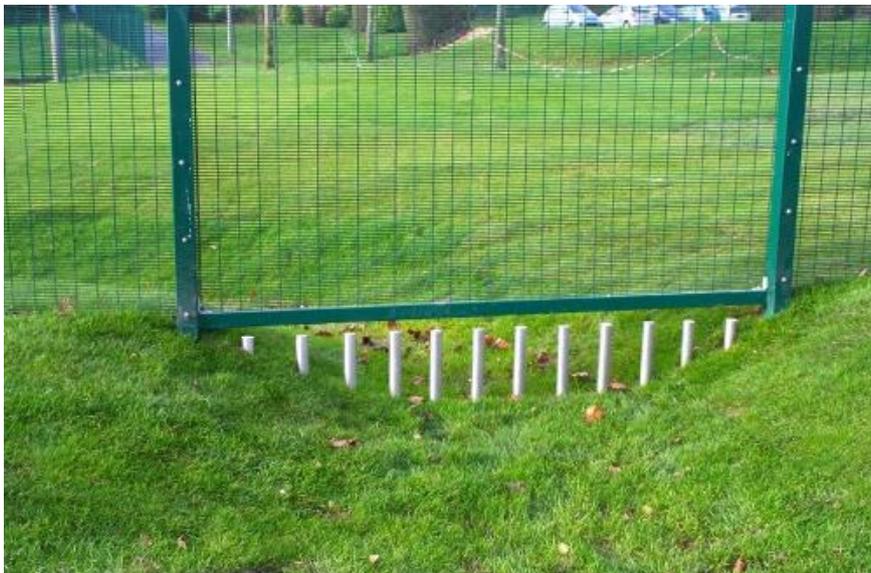
Figure 2 Stainless steel pins provide security at the site's secure boundary

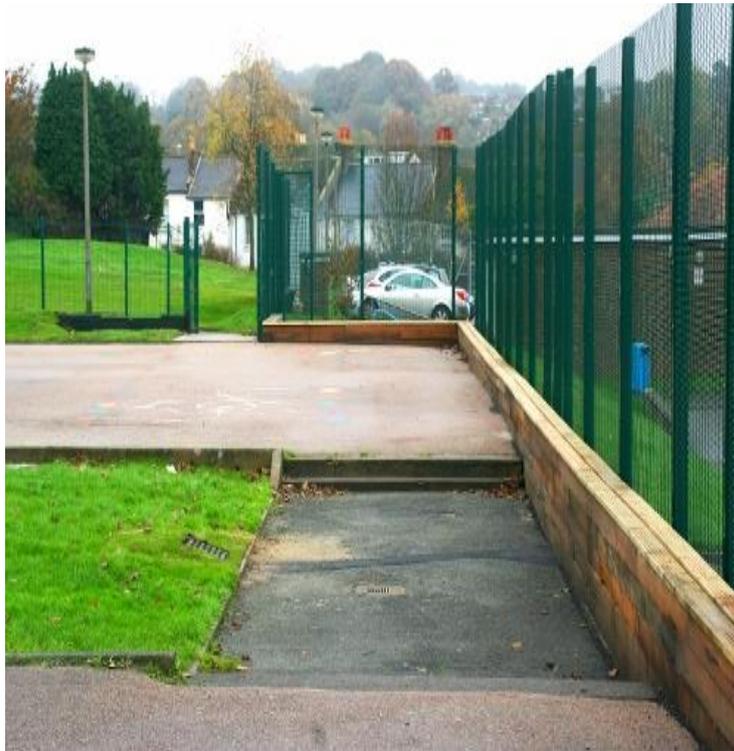
Figure 3 Timber seating wall converts an existing hard play area into a water large storage facility whilst providing added amenity for children

The main storage area is located within an existing hard play area. By creating a timber sleeper wall with sealant layers, along two sides of the play area, the play area can act as storage for larger storm events. For lower flows, a swale alongside the play area carries water toward a flow-controlled outlet. During larger storm events, as the storage area begins to fill, water will begin to pass through a slot weir and along a swale before being allowed to return to the sewer.

Topography prohibited the use of basin storage requiring an innovative solution to adapting an existing playground area as storage.

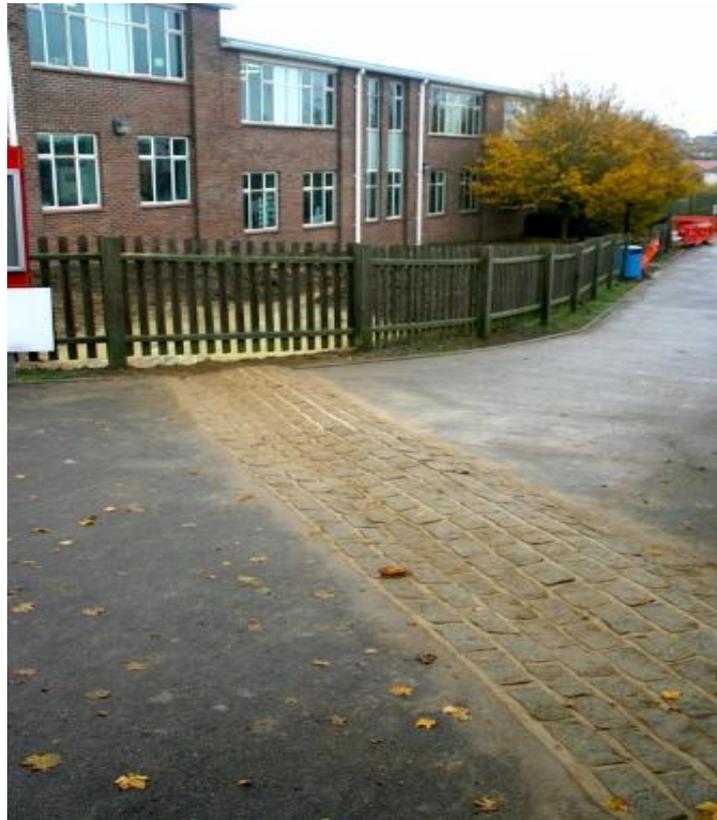
Figure 4 Granite sett flow diverter comprising combined channel and hump in a wave-like formation. The channel intercepts overland flow and diverts it to the raingarden basins beyond the fence (shown during construction)

Another point of entry for overland flow into the site is along a second pedestrian entrance to the school. Here the flow is diverted by means of a sine-wave sett channel and raised hump into two rain garden basins. One rain garden flows into the next and each collects rainwater from the adjacent school roof. The lower rain garden discharges into a piped outlet that re-emerges out of the wall of a second hard play area. A sett channel directs this flow, via a cascade, to flow out of this storage swale enters the sewer via an orifice flow control chamber.
