Markham Vale North, Derbyshire

SuDS used

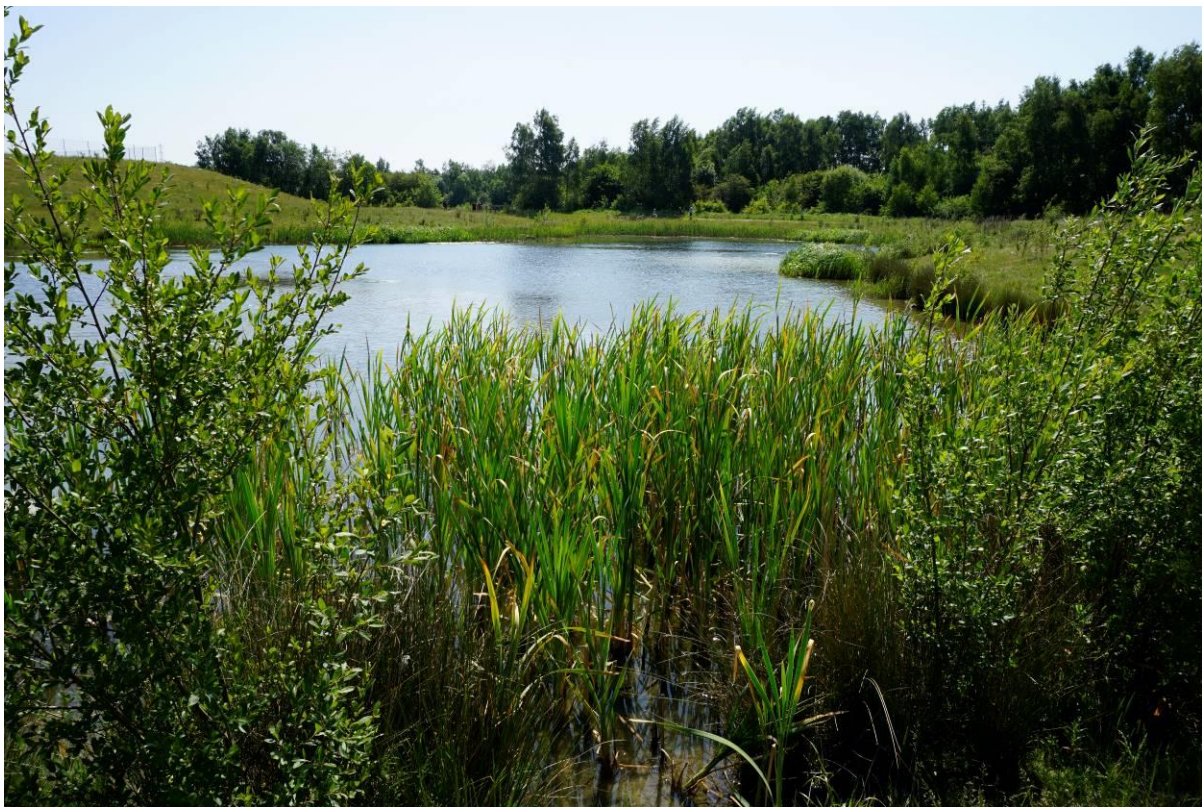
Fig 1 the largest pond in the Markham Vale North SuDs, designed to have permanent open water as well has storage capacity for a 100 + 30% flood event.

Within the land around the industrial platforms, eight retention ponds were formed (see separate drawing numbers 9033/1370 & 9033/1376). The retention ponds vary in capacity but all take the drainage from the hard surfaced elements of the site and process it by scrubbing, settlement and

biological interaction. Some of the retention ponds are interconnected, three discharge directly into Hawke Brook. The discharge from each pond is controlled by a piped outfall set low enough to drain the pond to maximise its storage capacity in extreme rain events but at a height that will retain a level of static water for ecological and environmental benefits. The diameter of the pipes and their respective invert levels have been calculated to restrict the flow into Hawke Brook to 5 litre per second per hectare and the system has been designed to accommodate a 100 year +30% flood event.

Some of the ponds have been designed to have a relatively shallow permanent water level, the intention being that these ponds will become populated by reeds and rushes whereas others have been designed to have large areas of open water. This mix of ponds with differing water levels has been provided in the interest of developing a variety of habitats and increasing biodiversity within the site. A key design feature of the ponds are their bank gradients, wherever possible these have been designed to be as gentle as possible to maximise the transition area from water through wetland to grassland to provide diverse habitats and opportunities in which indigenous flora can populate and thrive. The gentle bank gradients are also visually pleasant and contribute significantly to the naturalistic appearance of the site.

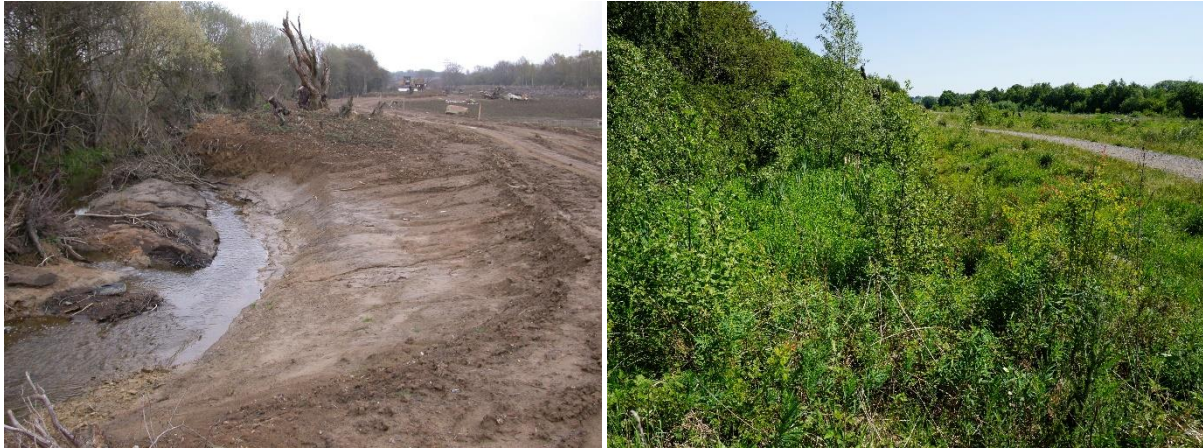
Fig 5 (left) 15th April 2016, illustrates the works undertaken to de-canalise Hawke Brook. On this section banks slopes were reduced, the width was increased and a second channel formed to accommodate flood waters and allow them to loose energy and deposit silts.

Fig 6 (right) 31st May 2020, shows the same view as shown in Fig 1 four years later. With the exception of the grasses all of the vegetation that can be seen within the second channel is the result of natural regeneration promoted by the de-canalisation and removal of overshadowing trees. The primary channel in which Hawke Brook runs remains as open, flowing water.

The de-canalisation of Hawke Brook has been something that officers working for the Environment Agency (EA) have suggested and requested since Derbyshire County Council purchased the site. The results of surveys undertaken on behalf of the EA had identified that Hawke Brook would benefit from improvements to biodiversity and water quality in line with the EU Water Framework Directive (WFD). The improvements that have been undertaken are visible by the diversity of flora that has established within the brook and along its banks. Small fish can be seen along its length which is a good indicator that the brook is in a good condition. The de-canalised banks now allow floodwater to overtop, lose energy and deposit silt as it passes over grassland. The vegetation that now grows on the stream bed and along the banks help to retain the stones of the streambed and also cause the deposition of silt which is assisting in maintaining and developing the streambed as a habitat.
